WATERSHED AND REACH SCALE INVESTIGATION OF EXISTING CONDITIONS

MANASTASH CREEK CORRIDOR HABITAT ENHANCEMENT AND FLOOD HAZARD REDUCTION PLAN

Prepared for
Kittitas County Conservation District

November 1', 2012

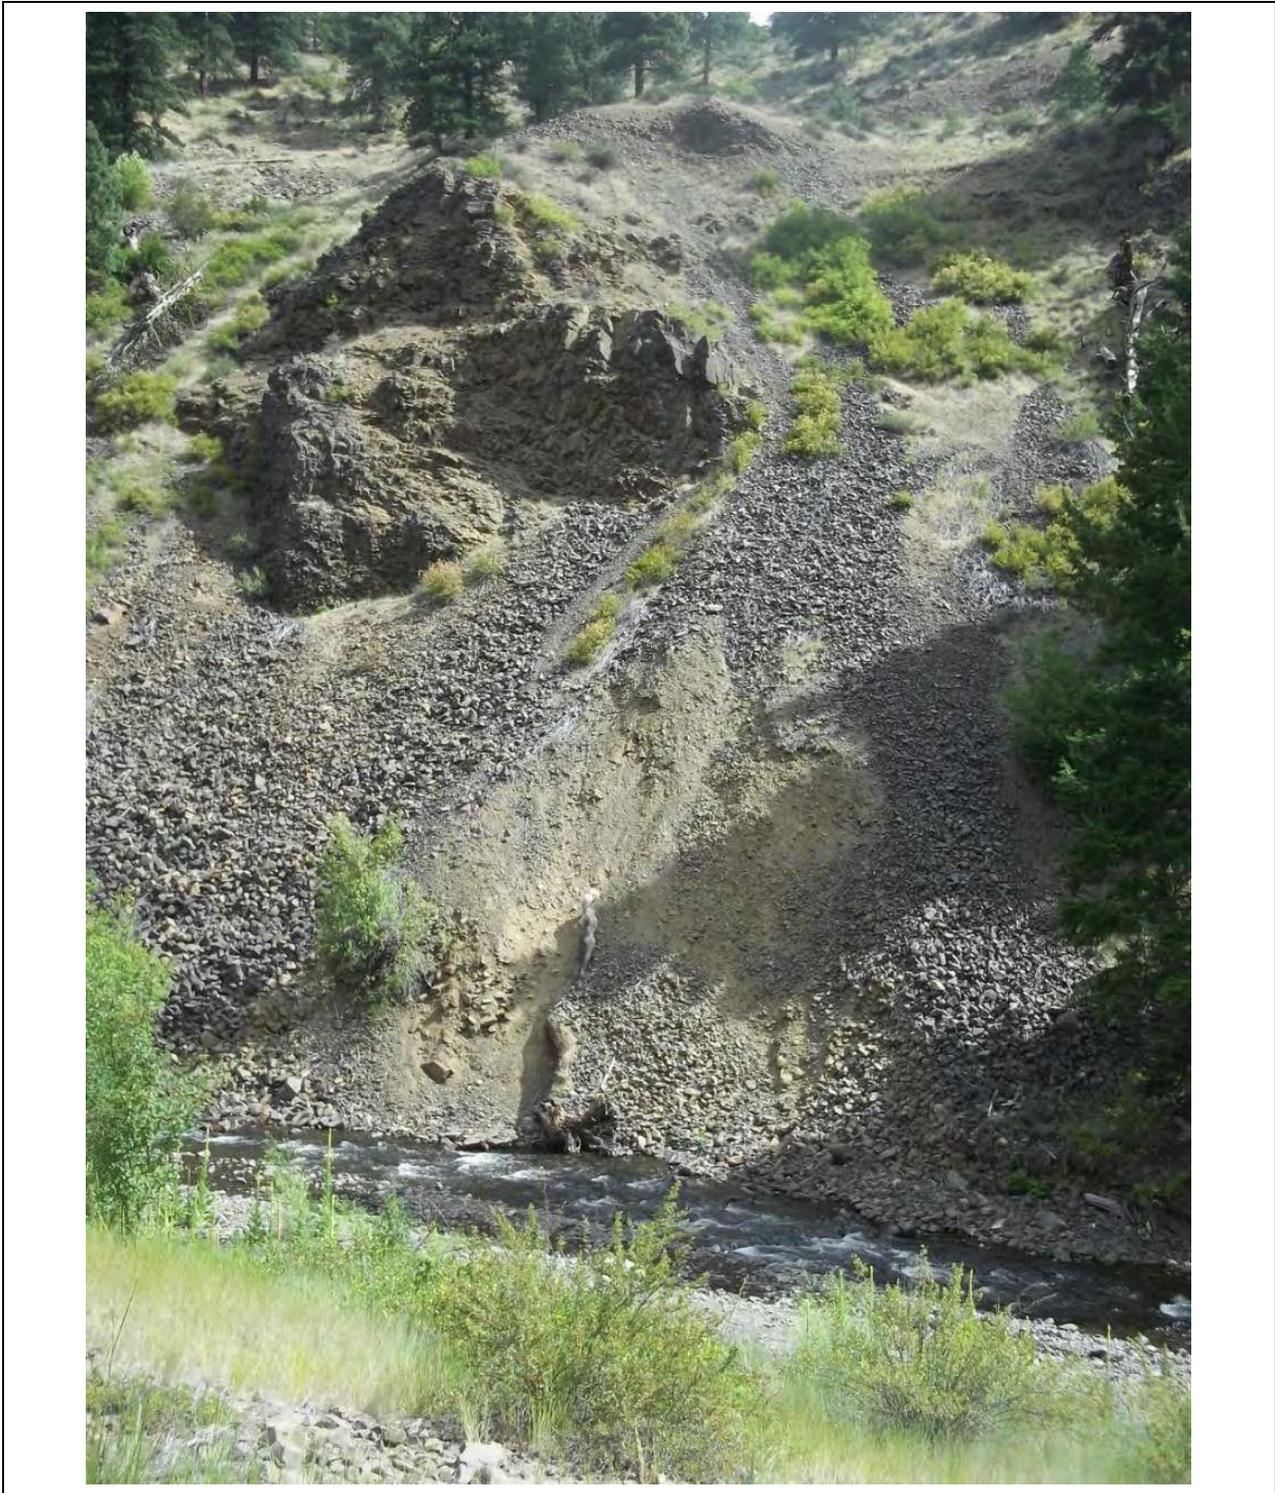
Figure 4. Photograph of Active Sediment Delivery in Manastash Canyon.

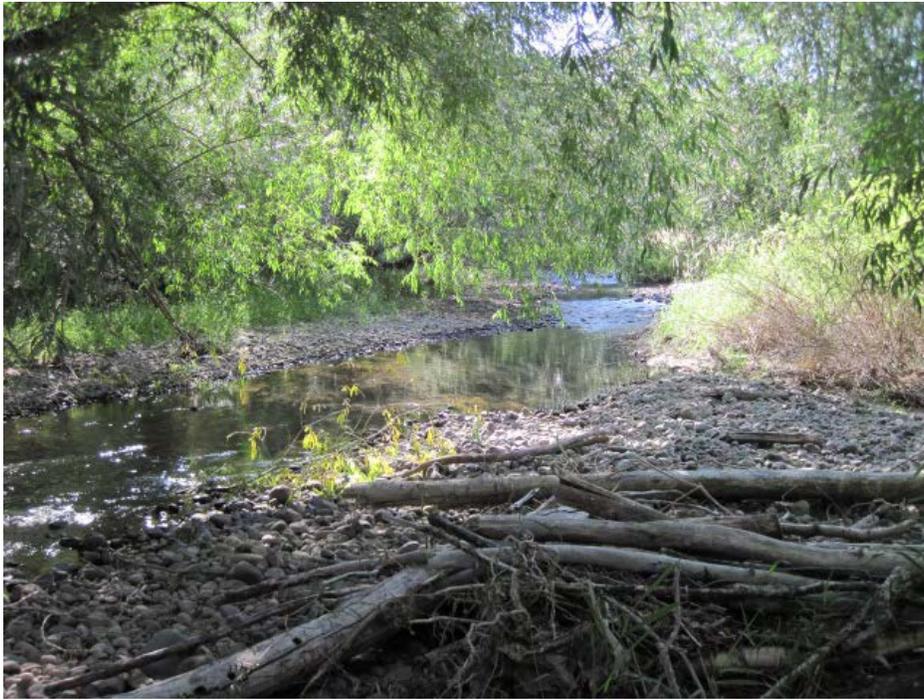
Photo D1. Stream channel and riparian habitat conditions in Reach YC.

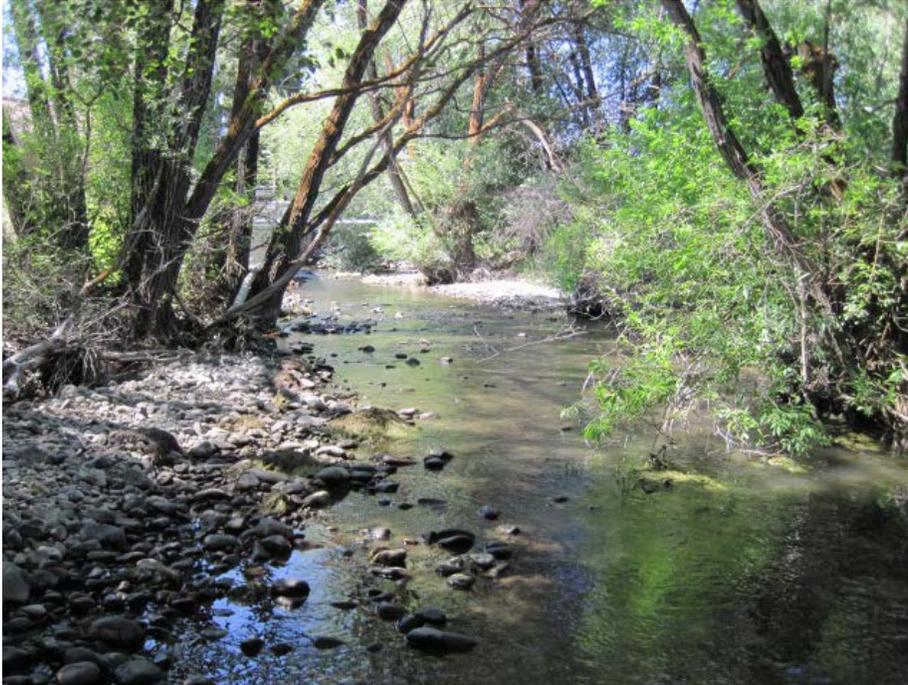
Photo D2. Stream channel and riparian habitat conditions in Reach BC1 downstream of Brown Road.

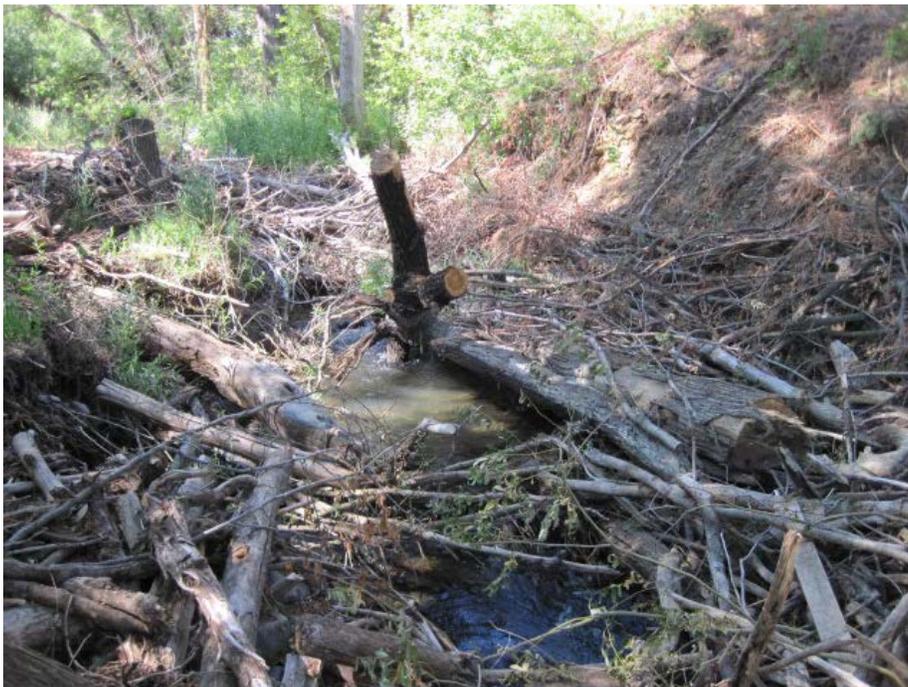
Photo D3. Large wood accumulation in Reach BC1.

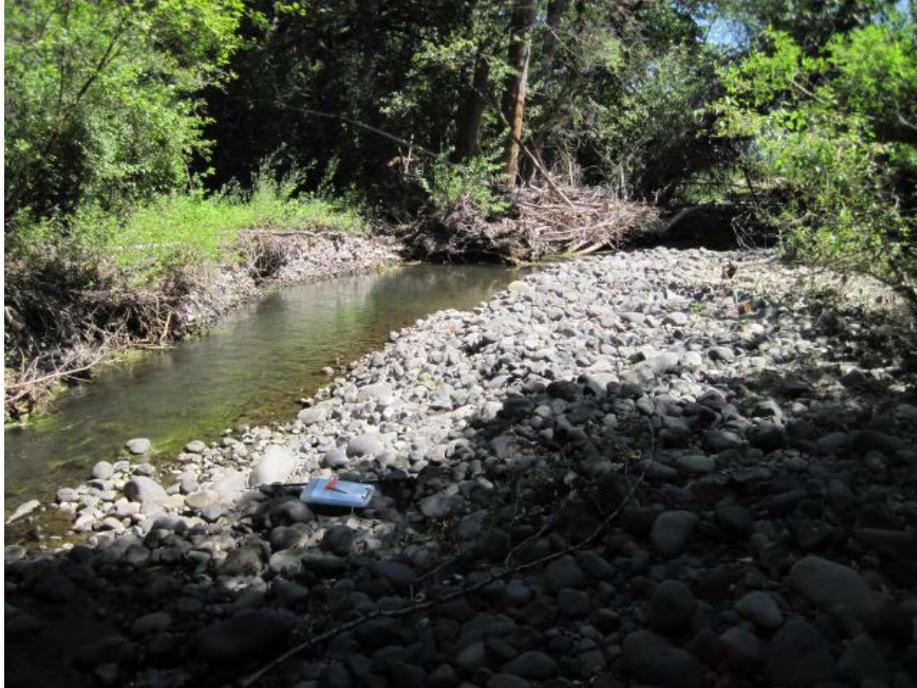
Photo D4. Algae growth in stream channel and riparian habitat conditions in Subreach BC3.

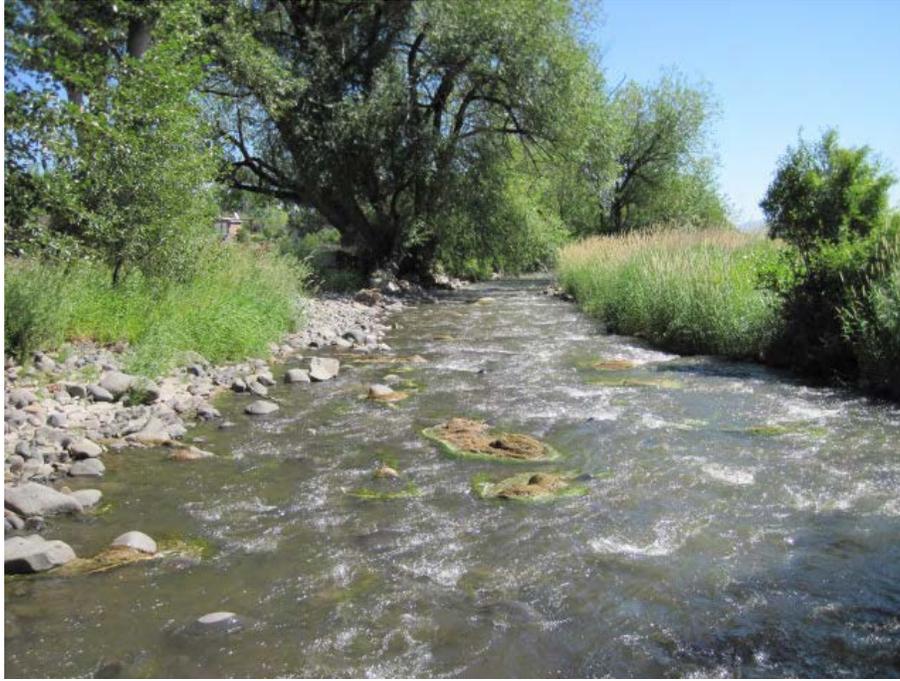
Photo D5. Turbid water and algae in stream channel in Subreach SC1.

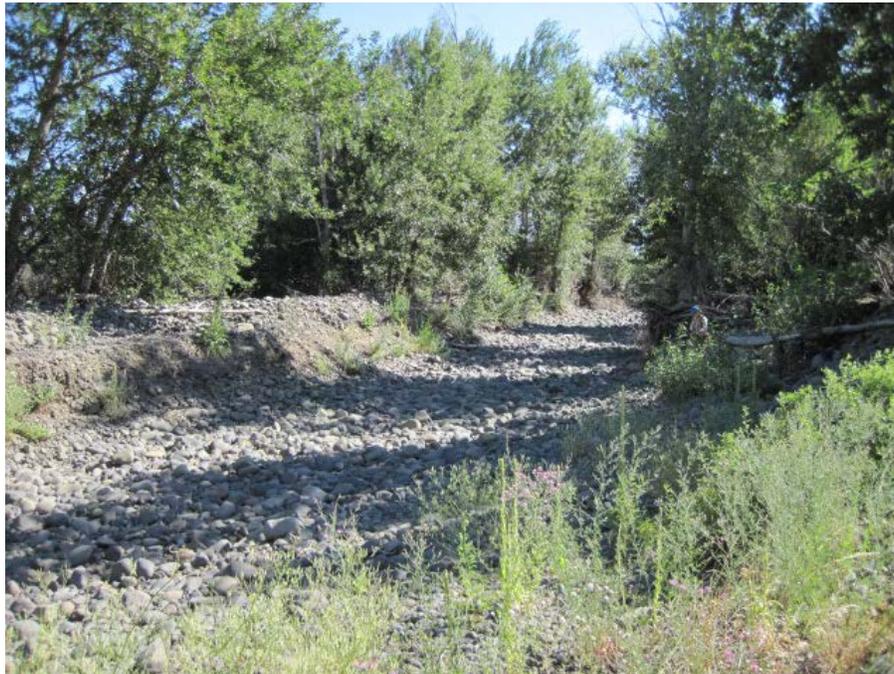
Photo D6. Dry stream channel conditions in Subreach SC2.

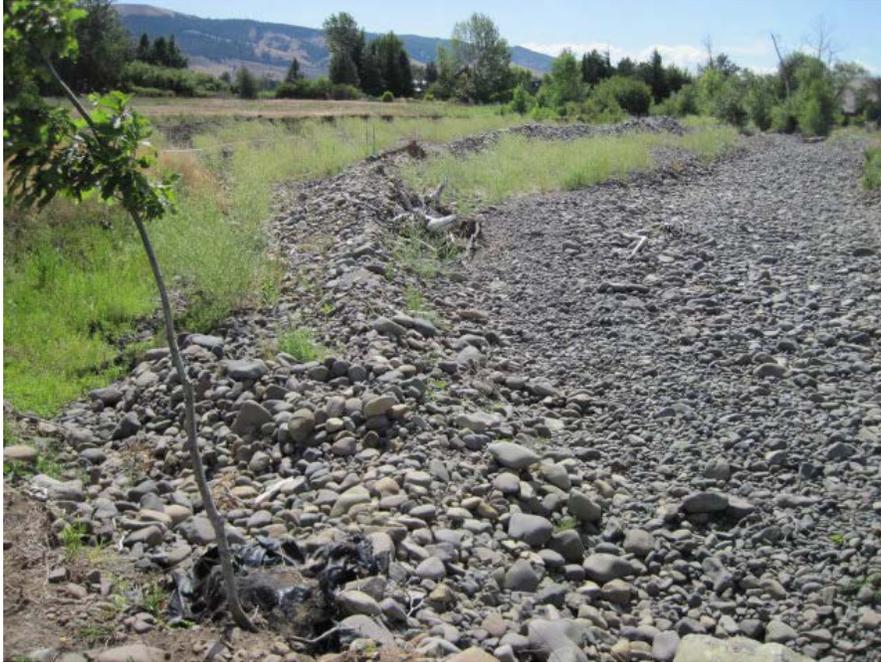
Photo D7. Dry stream channel, gravel berms, and unvegetated riparian conditions in Subreach FC1.

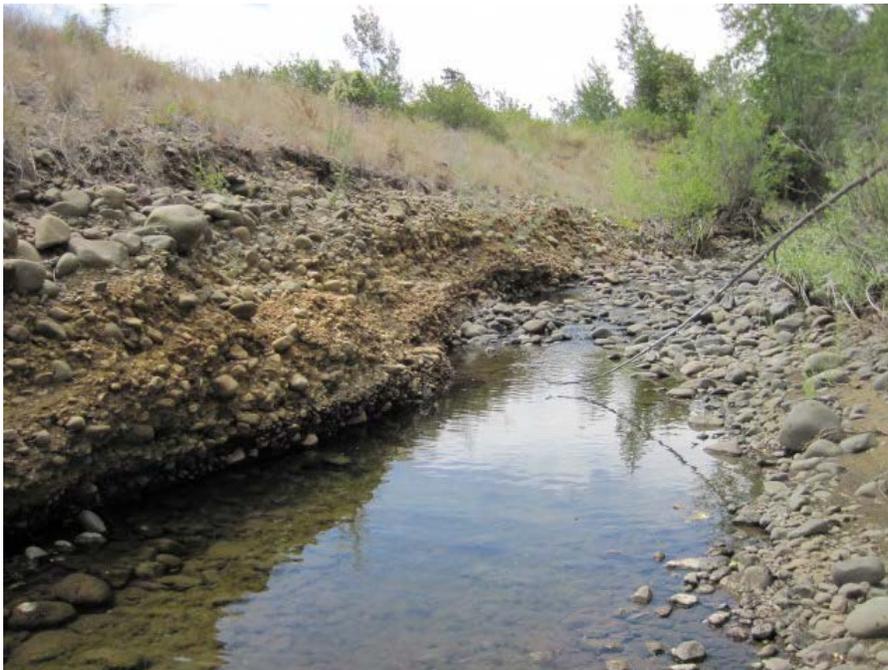
Photo D8. Groundwater fed base flow within confined stream channel in Subreach FC2.

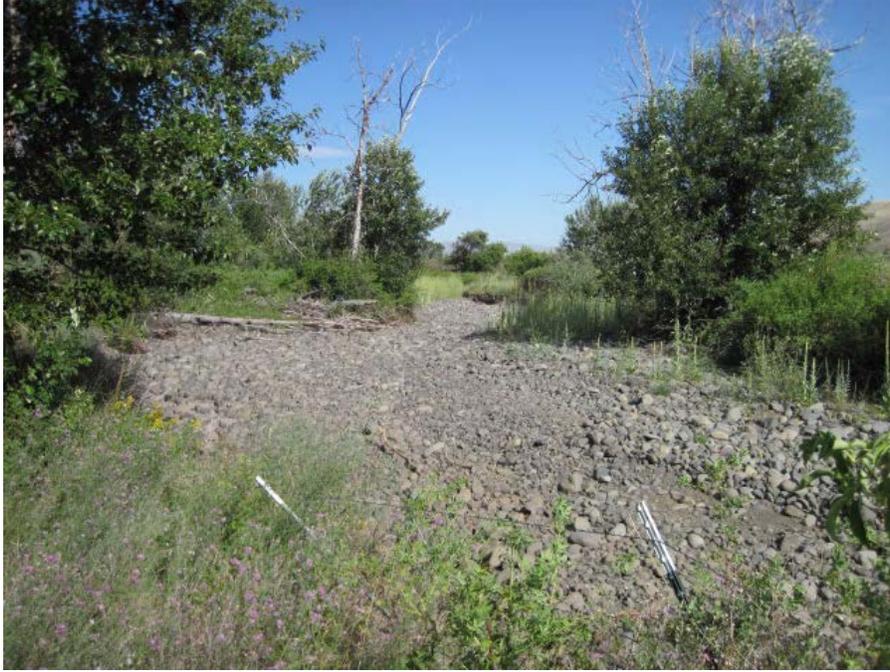
Photo D9. Dry stream channel and riparian habitat conditions in Subreach FC4.

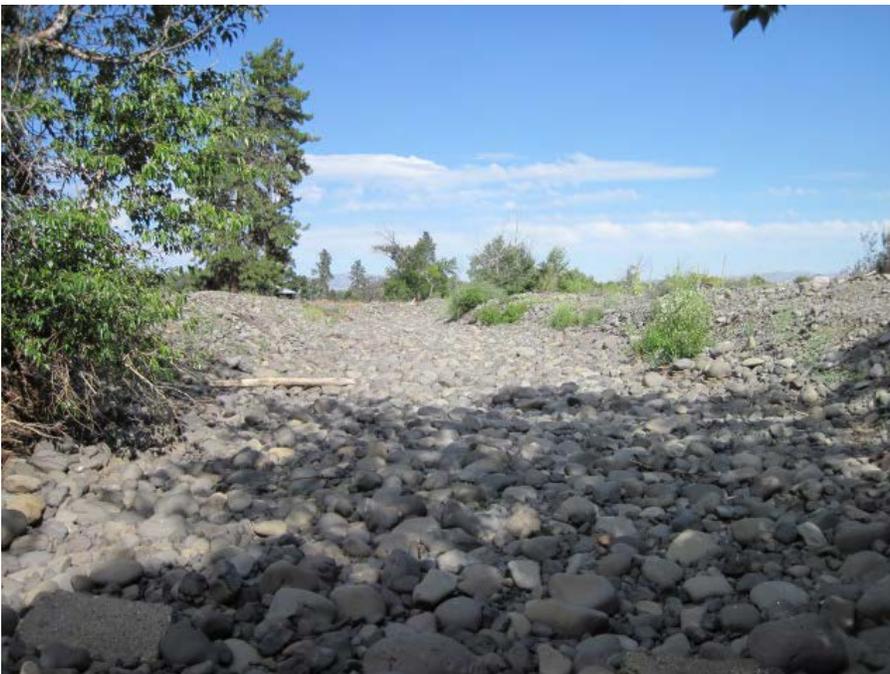
Photo D10. Dry stream channel and riparian habitat conditions in Subreach FC5.

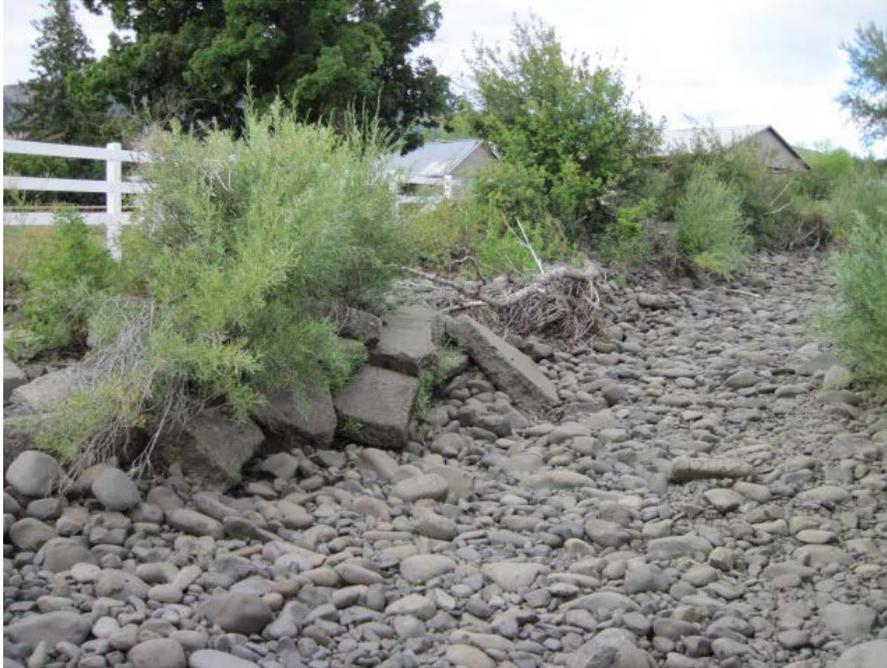
Photo D11. Dry stream channel and berm/revetment upstream of Cove Road in Subreach FE1.

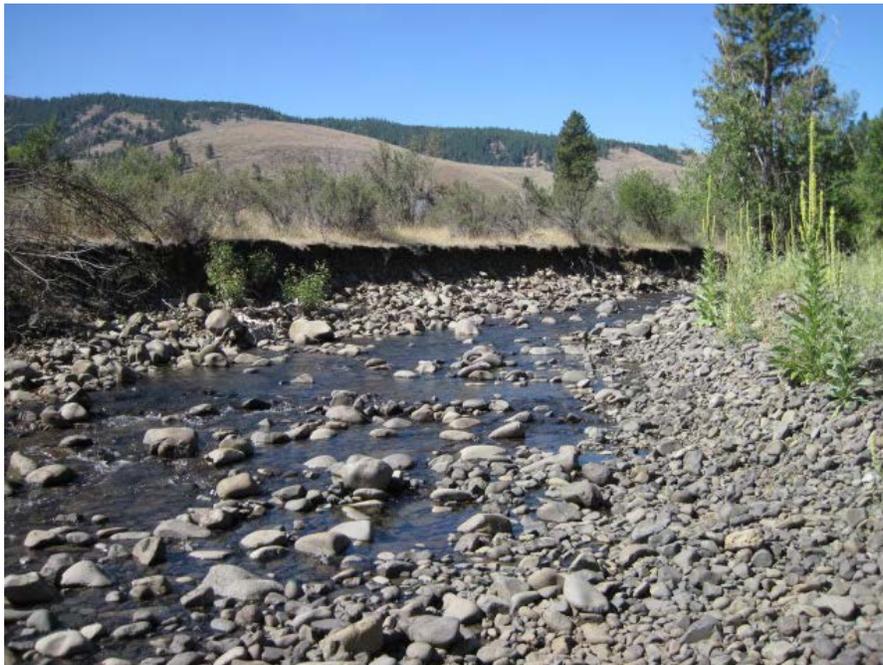
Photo D12. Stream channel and riparian habitat conditions in Subreach FE2.

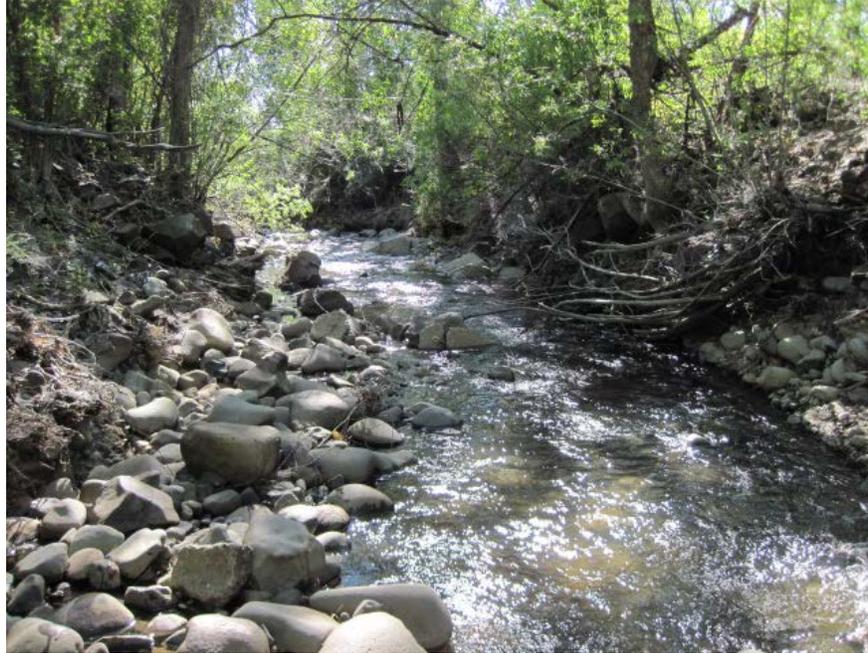
Photo D13. Entrenched stream channel and riparian habitat conditions downstream of Reed diversion in Subreach FE3.

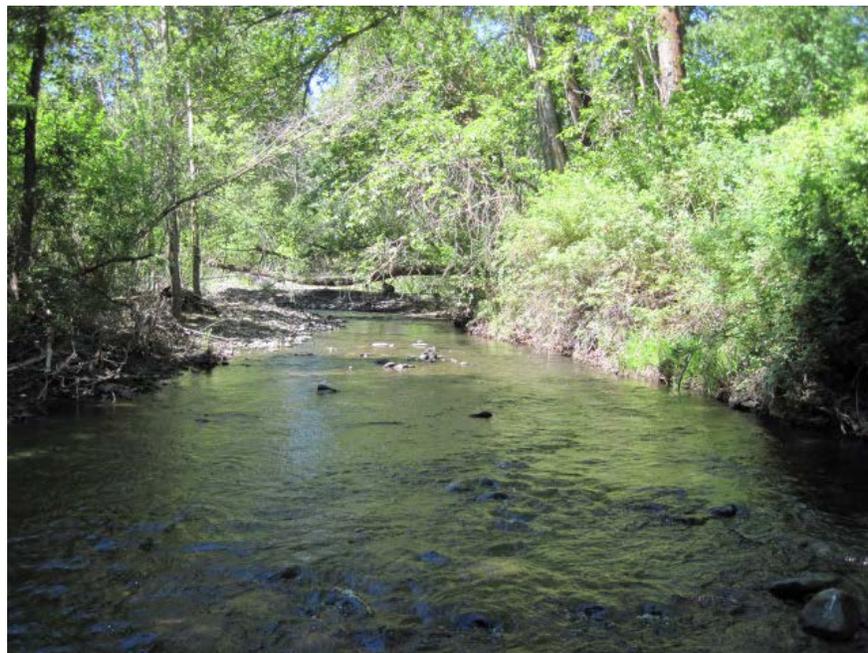
Photo D14. Stream channel and riparian habitat conditions in Subreach FE4.

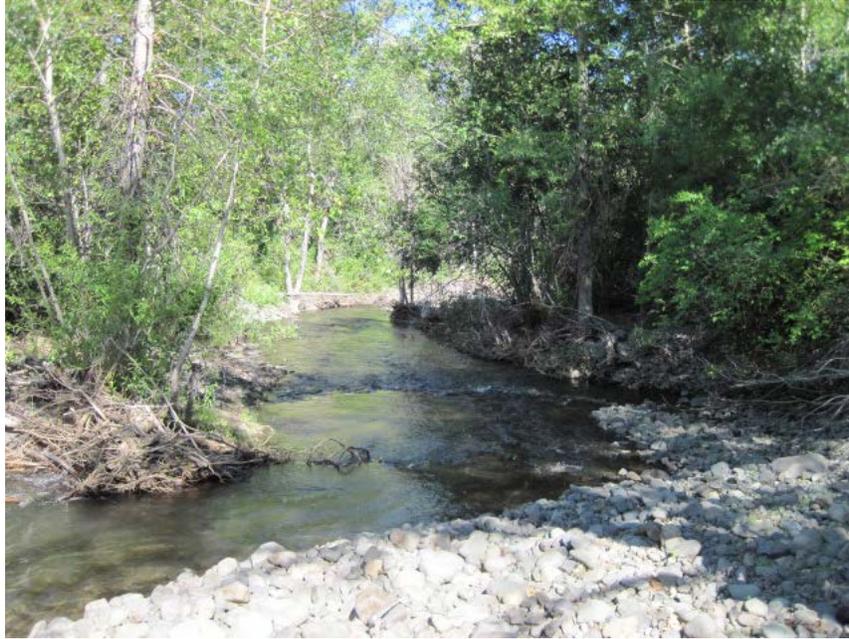
Photo D15. Stream channel and riparian habitat conditions in Subreach FA1.

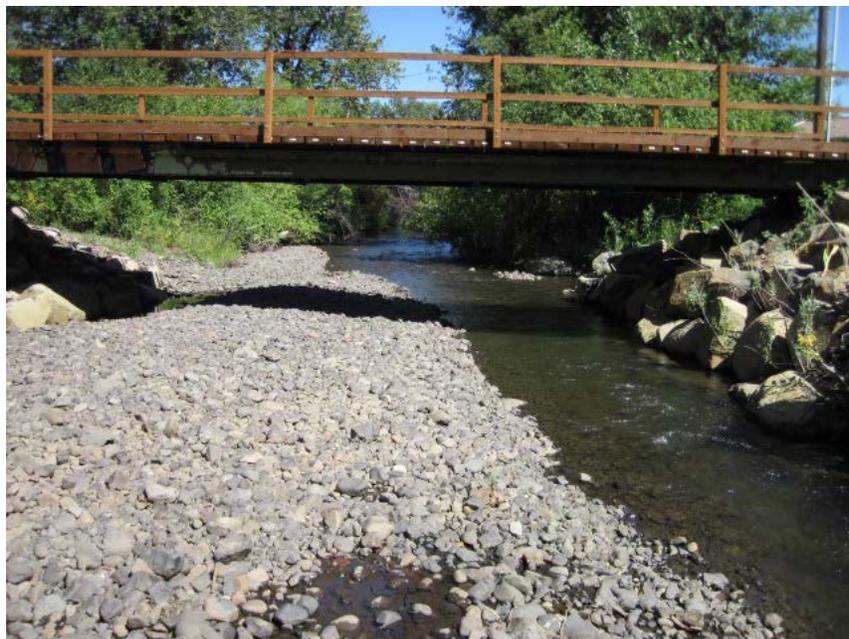
Photo D16. Stream channel and bridge in Subreach FA2.

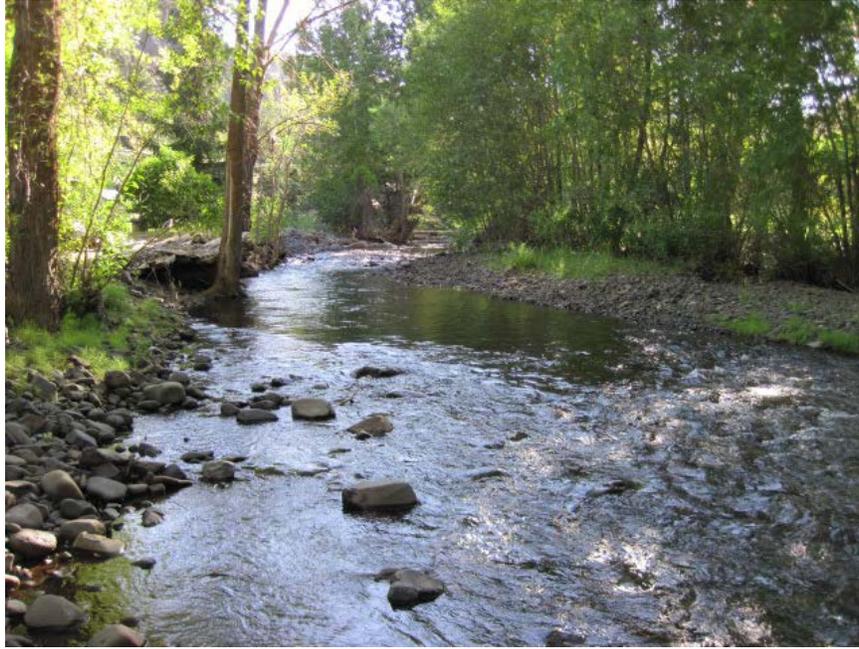
Photo D17. Stream channel and riparian habitat conditions in Subreach FA4.

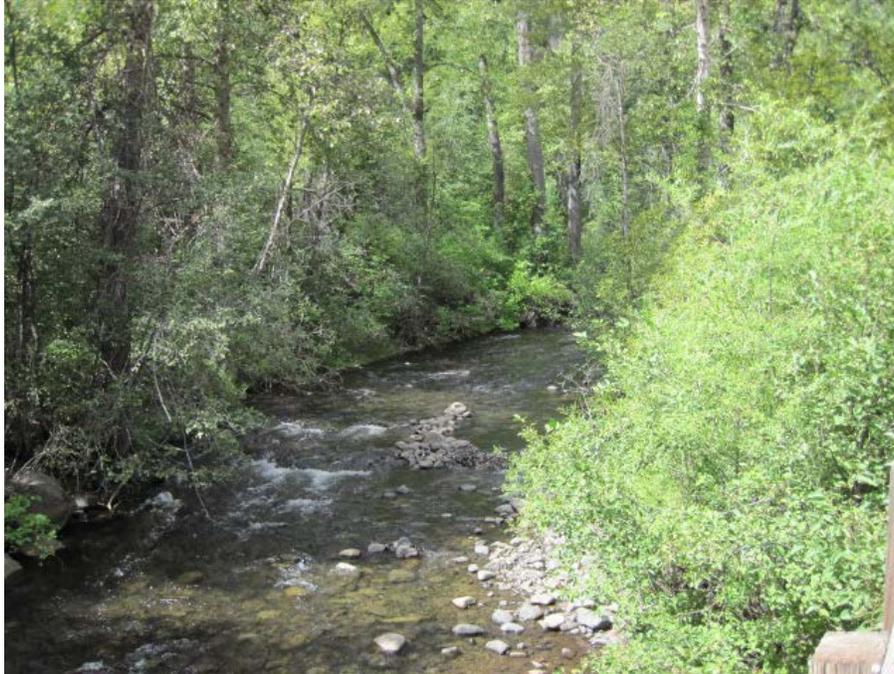
Photo D18. Stream channel and riparian habitat conditions in Reach CY.

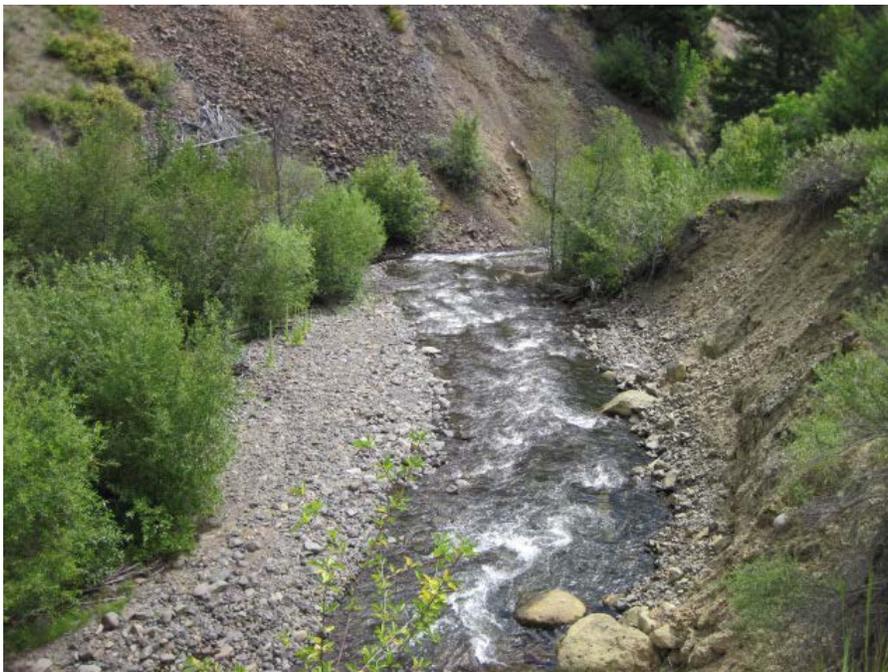
Photo D19. Stream channel and riparian habitat conditions in Reach CY.

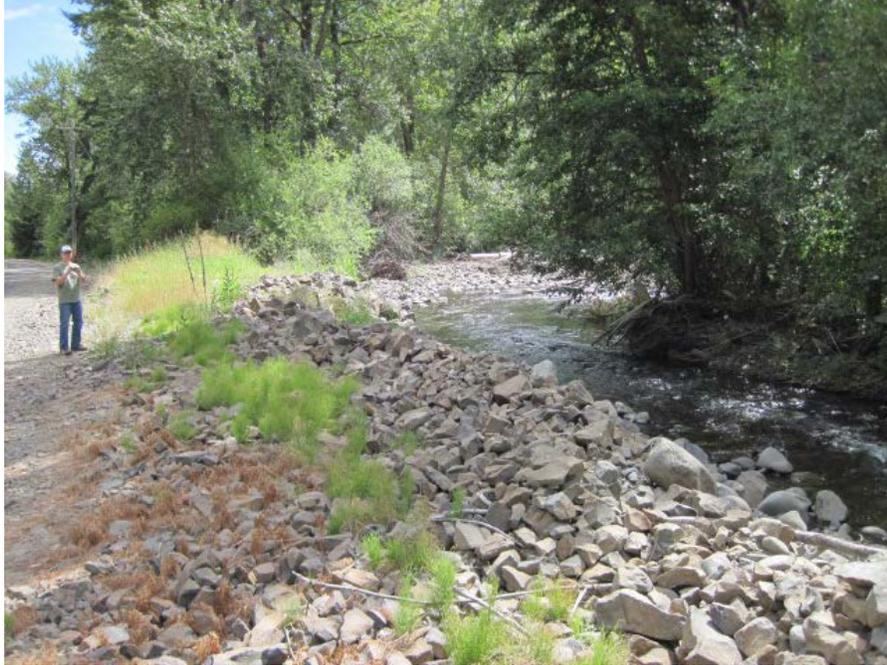
Photo D20. Gravel berm along Manastash Road in Reach CY.

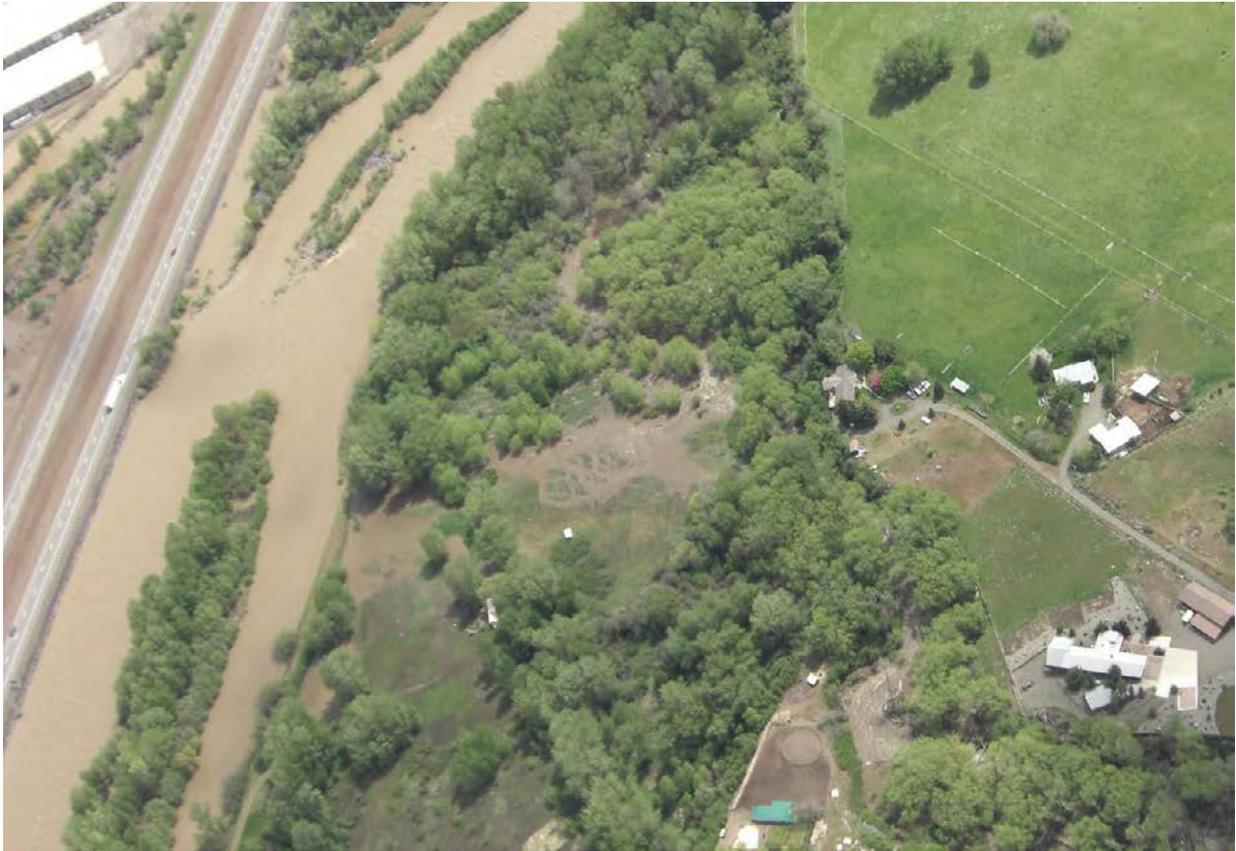
Photo 1YC. Viewing south along Yakima Confluence Reach during May 2011 flooding. The Yakima River is to the right and is flowing toward the top of the photograph (County photo).

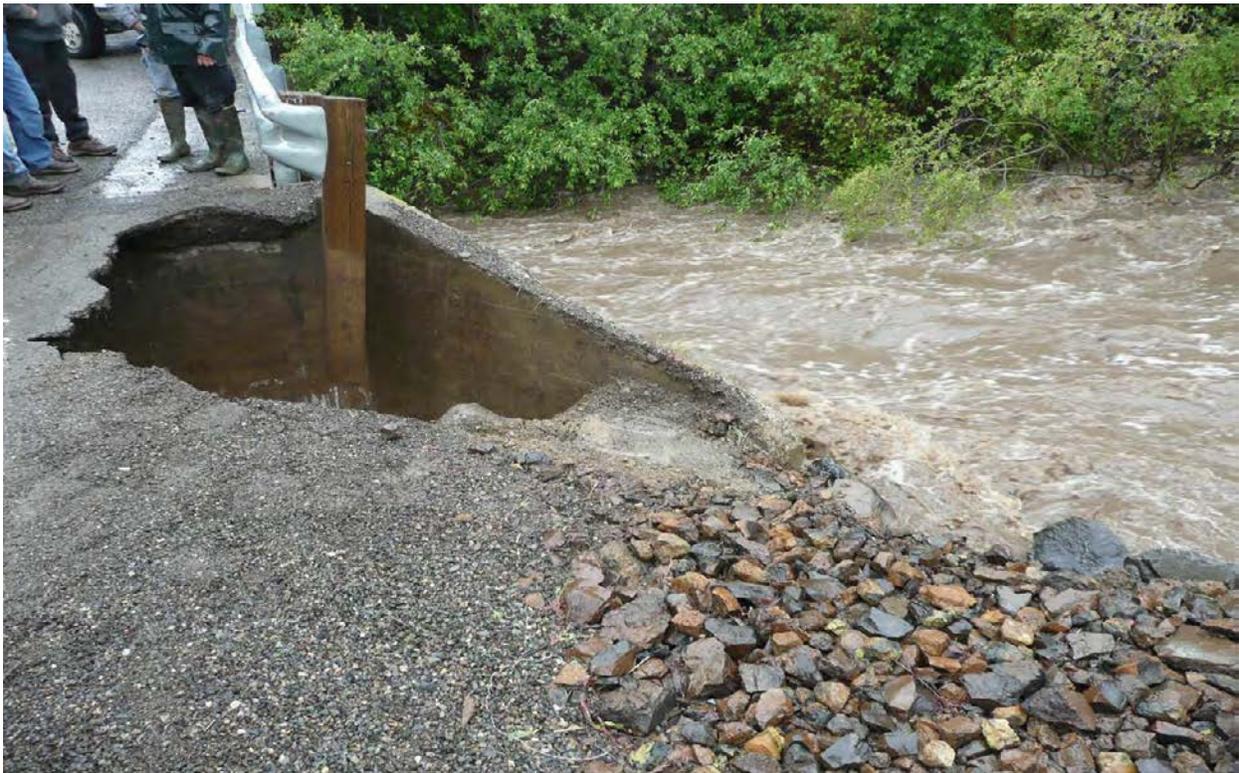
Photo 3ET. Barnes Road upstream left bank damage May 2011 flood.

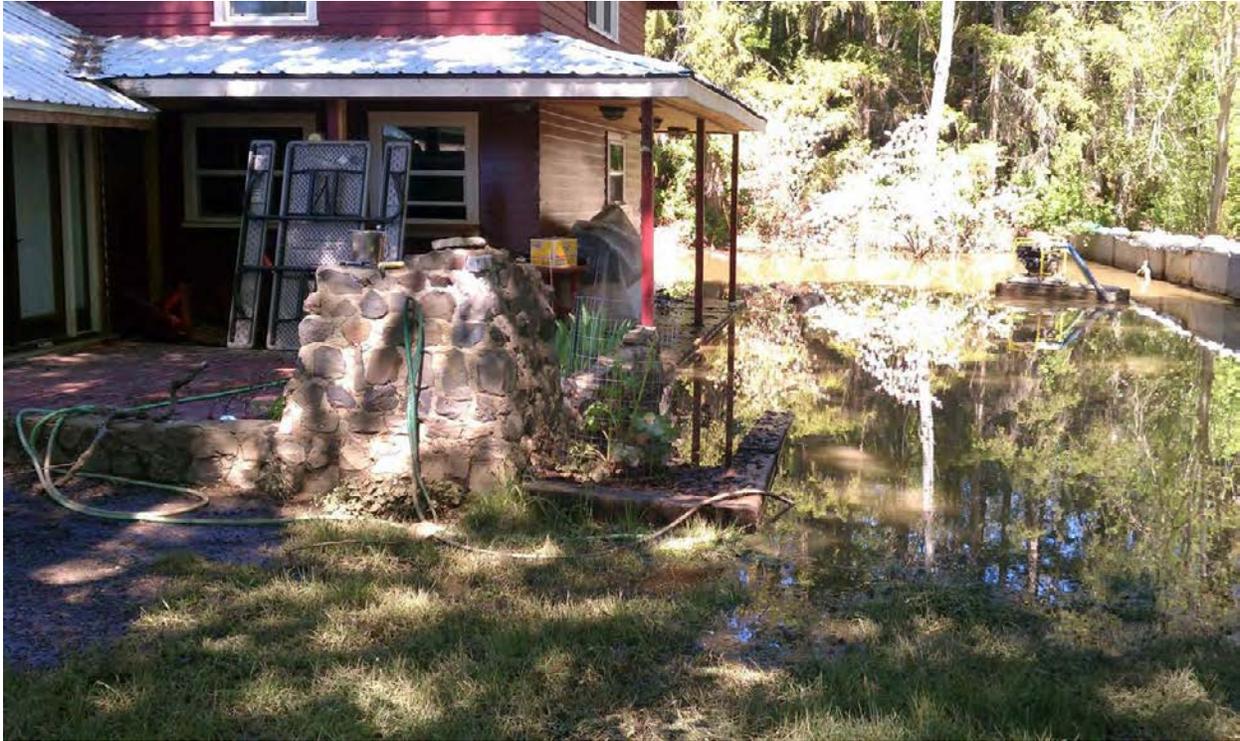
Photo 4ET. Water on the Wise property downstream of Brown Road during May 2011 flooding. This is one of the few structures located on the floor of the entrenched reach. Ecology blocks were used to construct a levee during/following flooding.

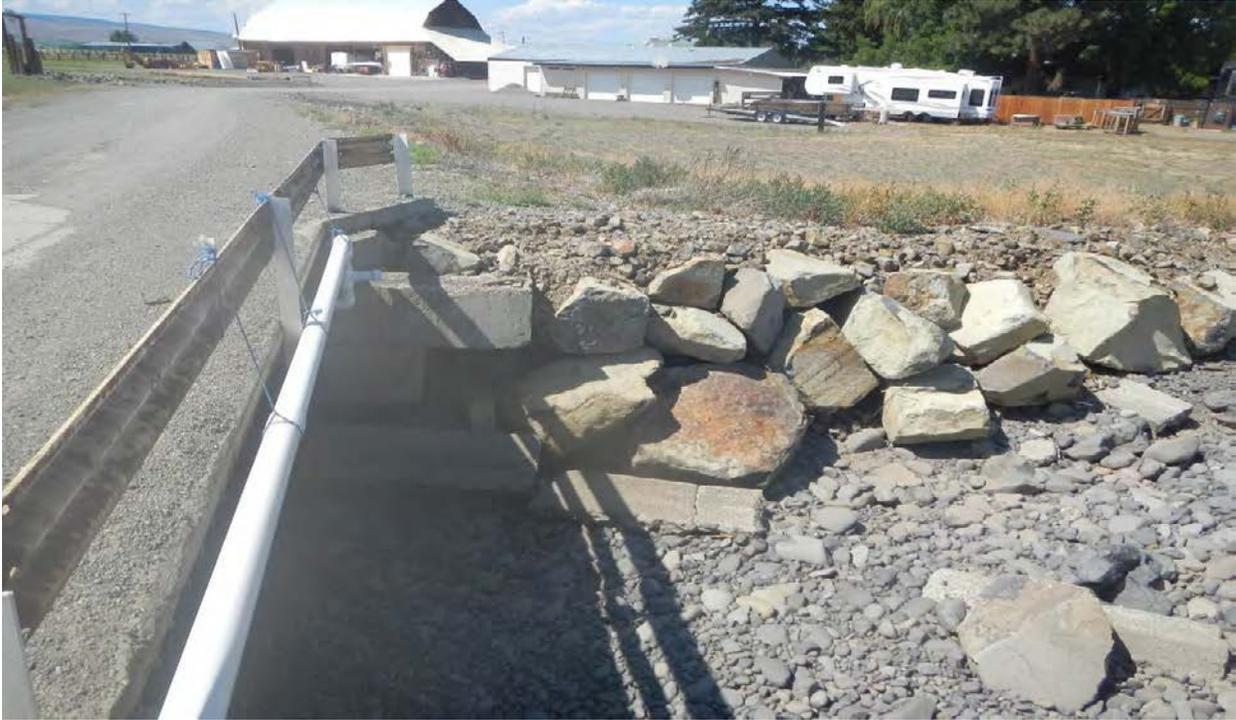
Photo 2FC. Viewing north to the downstream left bank abutment of Serenity Road bridge. Bridge abutments have been undermined and are in need of repair (July 25, 2012).

- **Bridge Replacement.** The Serenity Lane Bridge is too narrow and the abutments are in extremely poor condition. It should be replaced with a wider crossing. In addition, other undersized channel crossings (Cove Road, KRD South Branch Road, and KRD 13.8) should be considered for modification or replacement.

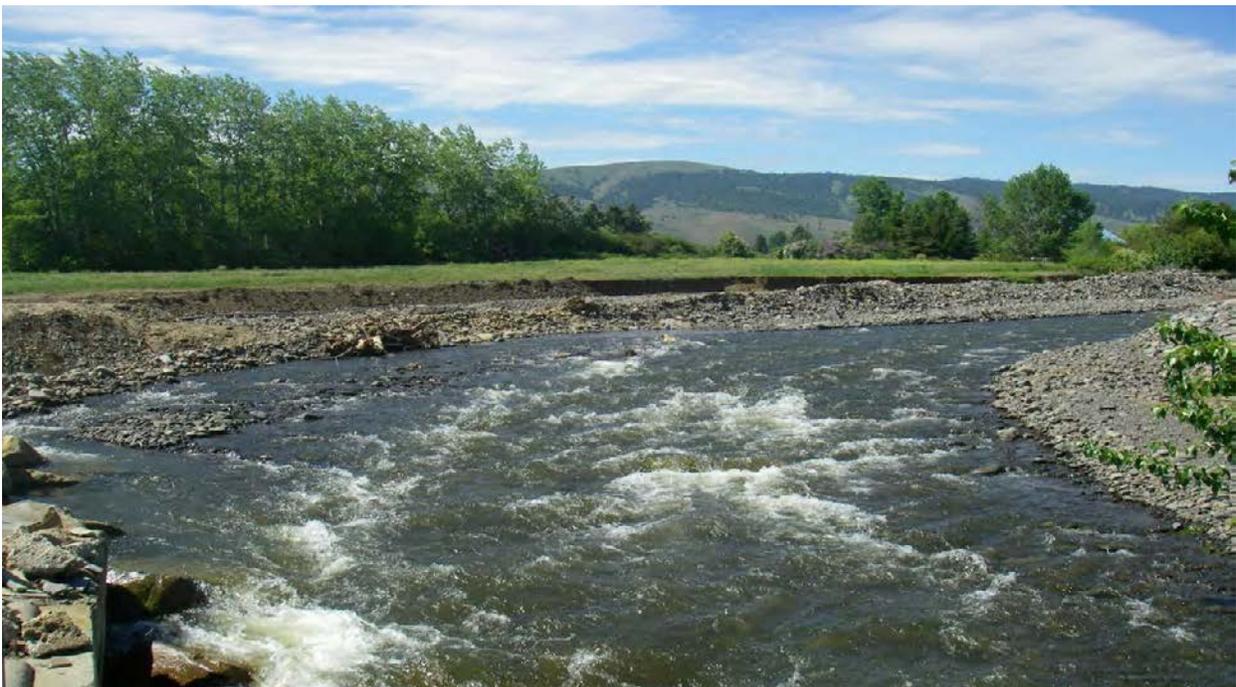
Photo 3FC. Viewing upstream from Serenity Lane Bridge after the May 2011 Flooding.
