Reach 21
Canyon 21
 (RM 12.5 to RM 13.2)

DRAFT

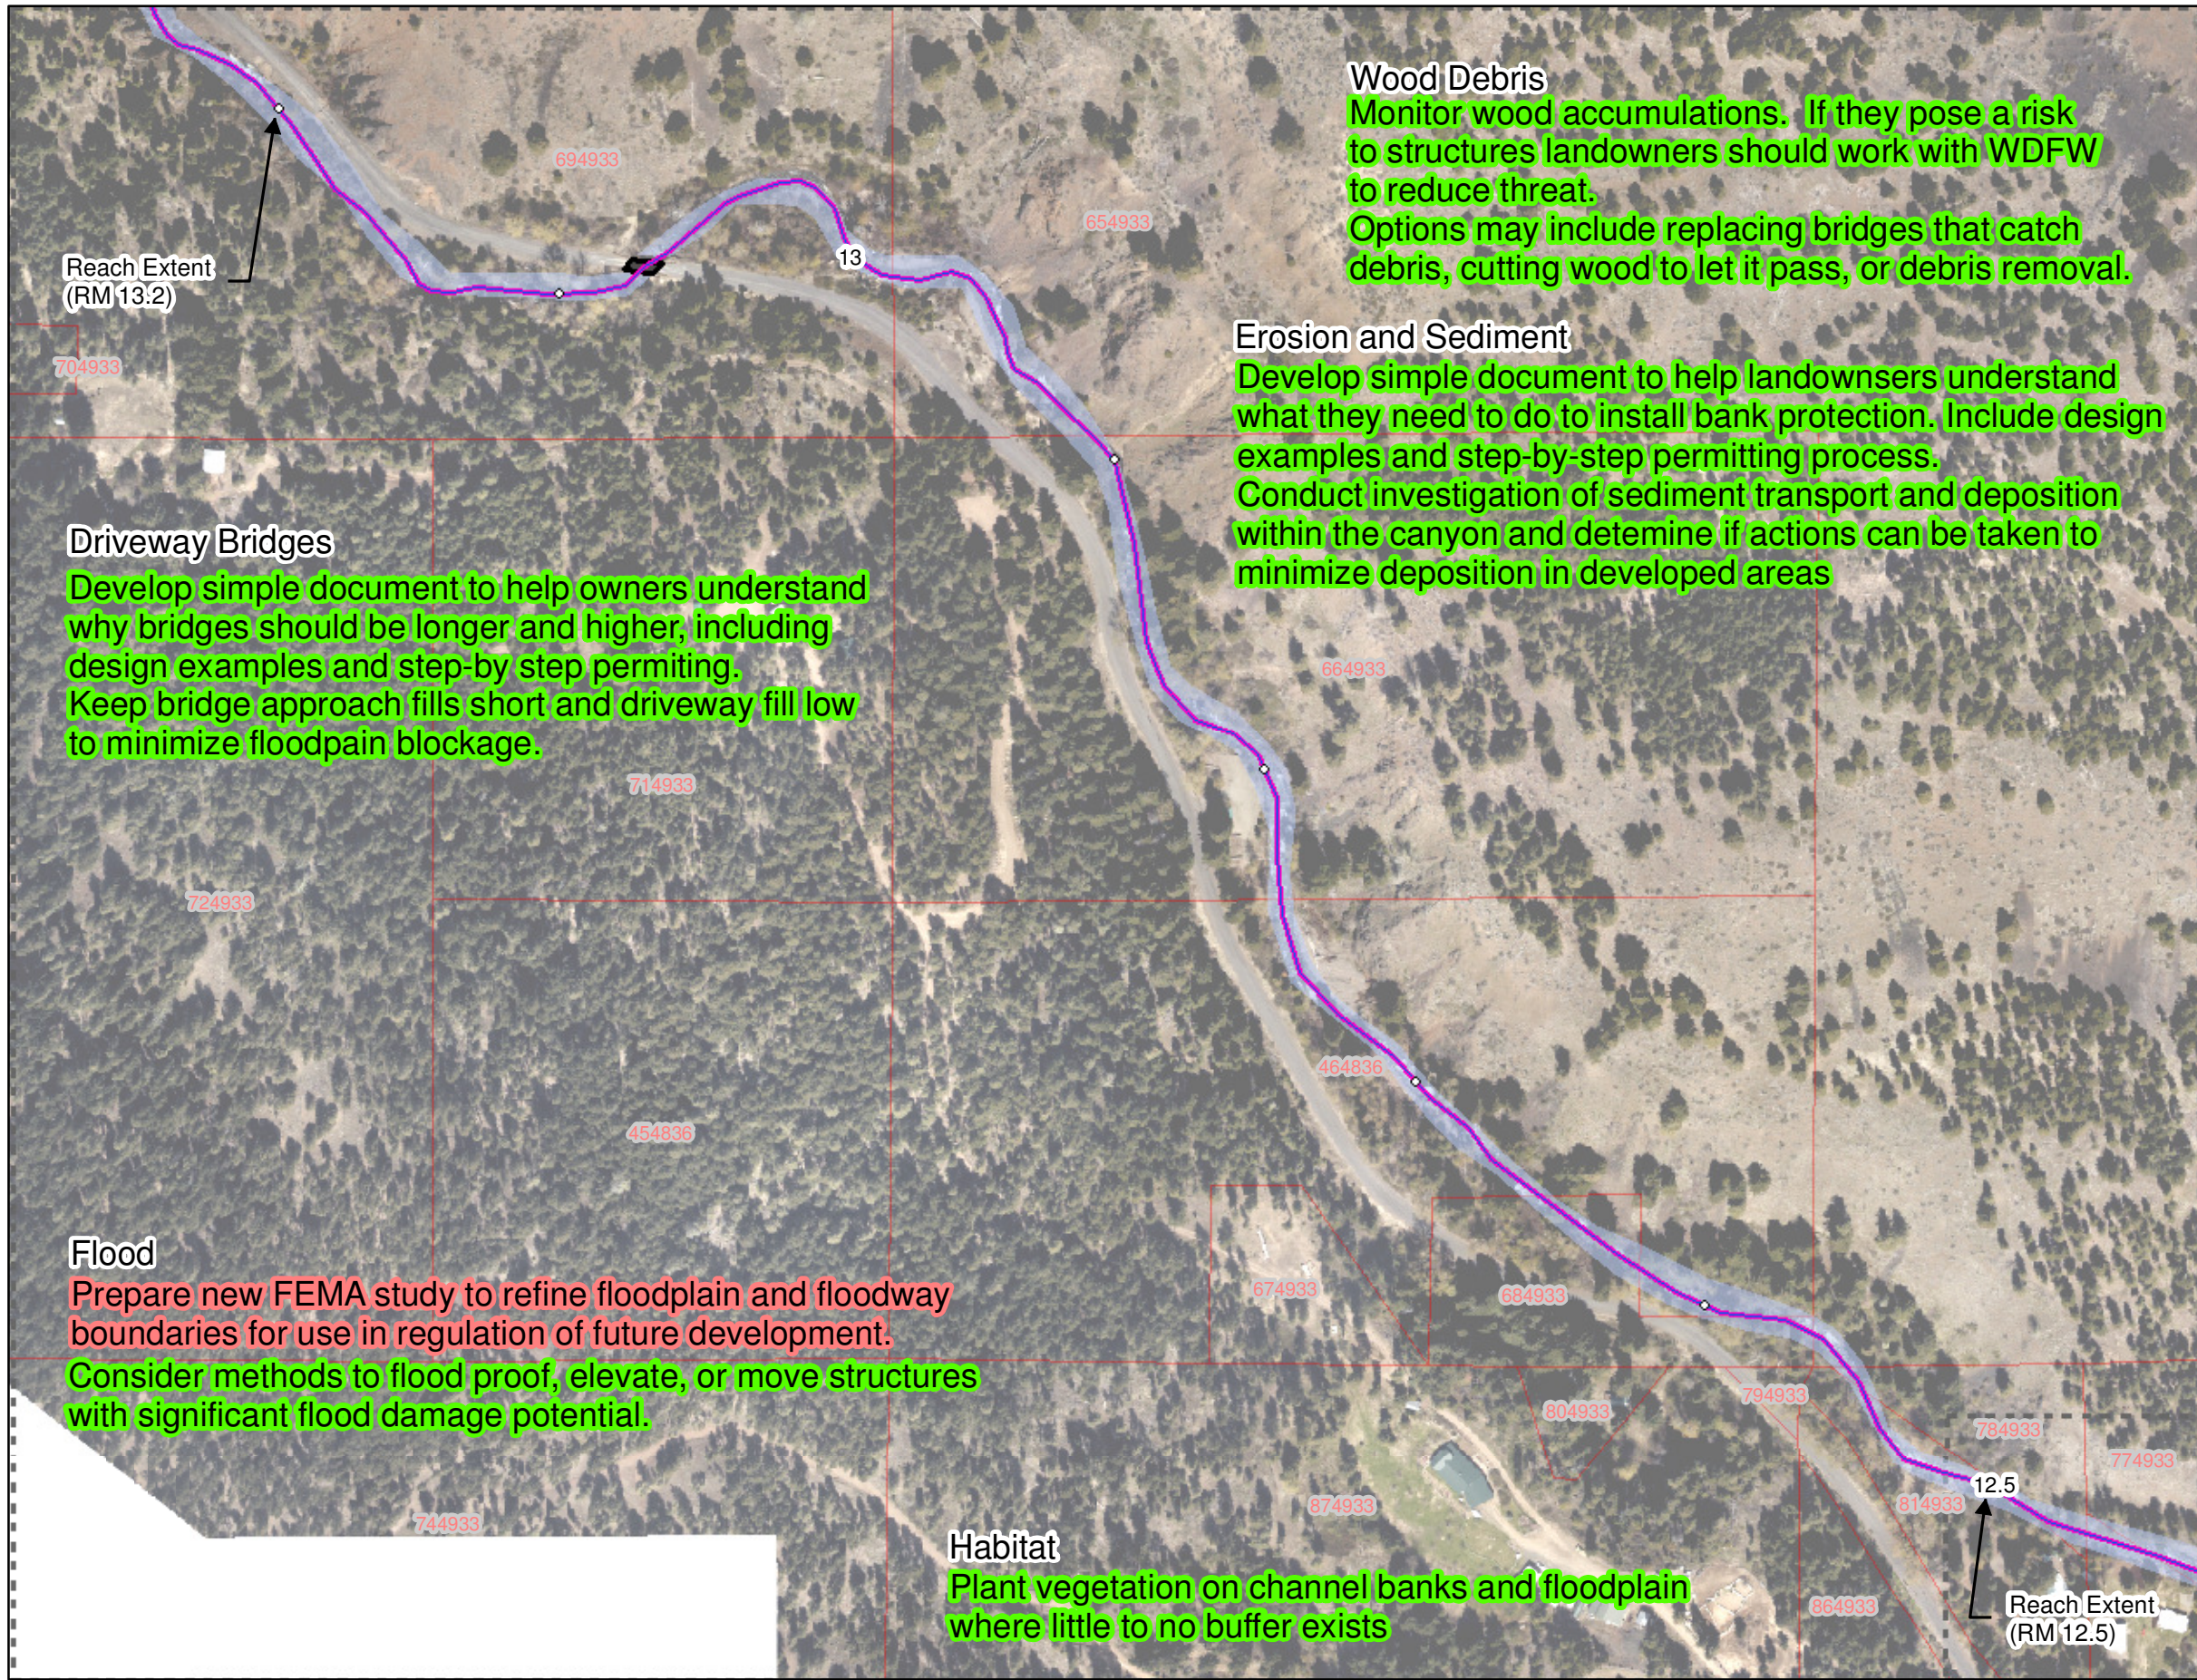
Wood Debris
 Monitor wood accumulations. If they pose a risk to structures landowners should work with WDFW to reduce threat.
 Options may include replacing bridges that catch debris, cutting wood to let it pass, or debris removal.

Erosion and Sediment
 Develop simple document to help landowners understand what they need to do to install bank protection. Include design examples and step-by-step permitting process.
 Conduct investigation of sediment transport and deposition within the canyon and determine if actions can be taken to minimize deposition in developed areas

Driveway Bridges
 Develop simple document to help owners understand why bridges should be longer and higher, including design examples and step-by-step permitting.
 Keep bridge approach fills short and driveway fill low to minimize floodplain blockage.

Flood
 Prepare new FEMA study to refine floodplain and floodway boundaries for use in regulation of future development.
 Consider methods to flood proof, elevate, or move structures with significant flood damage potential.

Habitat
 Plant vegetation on channel banks and floodplain where little to no buffer exists
