WATERSHED AND REACH SCALE INVESTIGATION OF EXISTING CONDITIONS

MANASTASH CREEK CORRIDOR HABITAT ENHANCEMENT AND FLOOD HAZARD REDUCTION PLAN

Prepared for
Kittitas County Conservation District

November 1', 2012

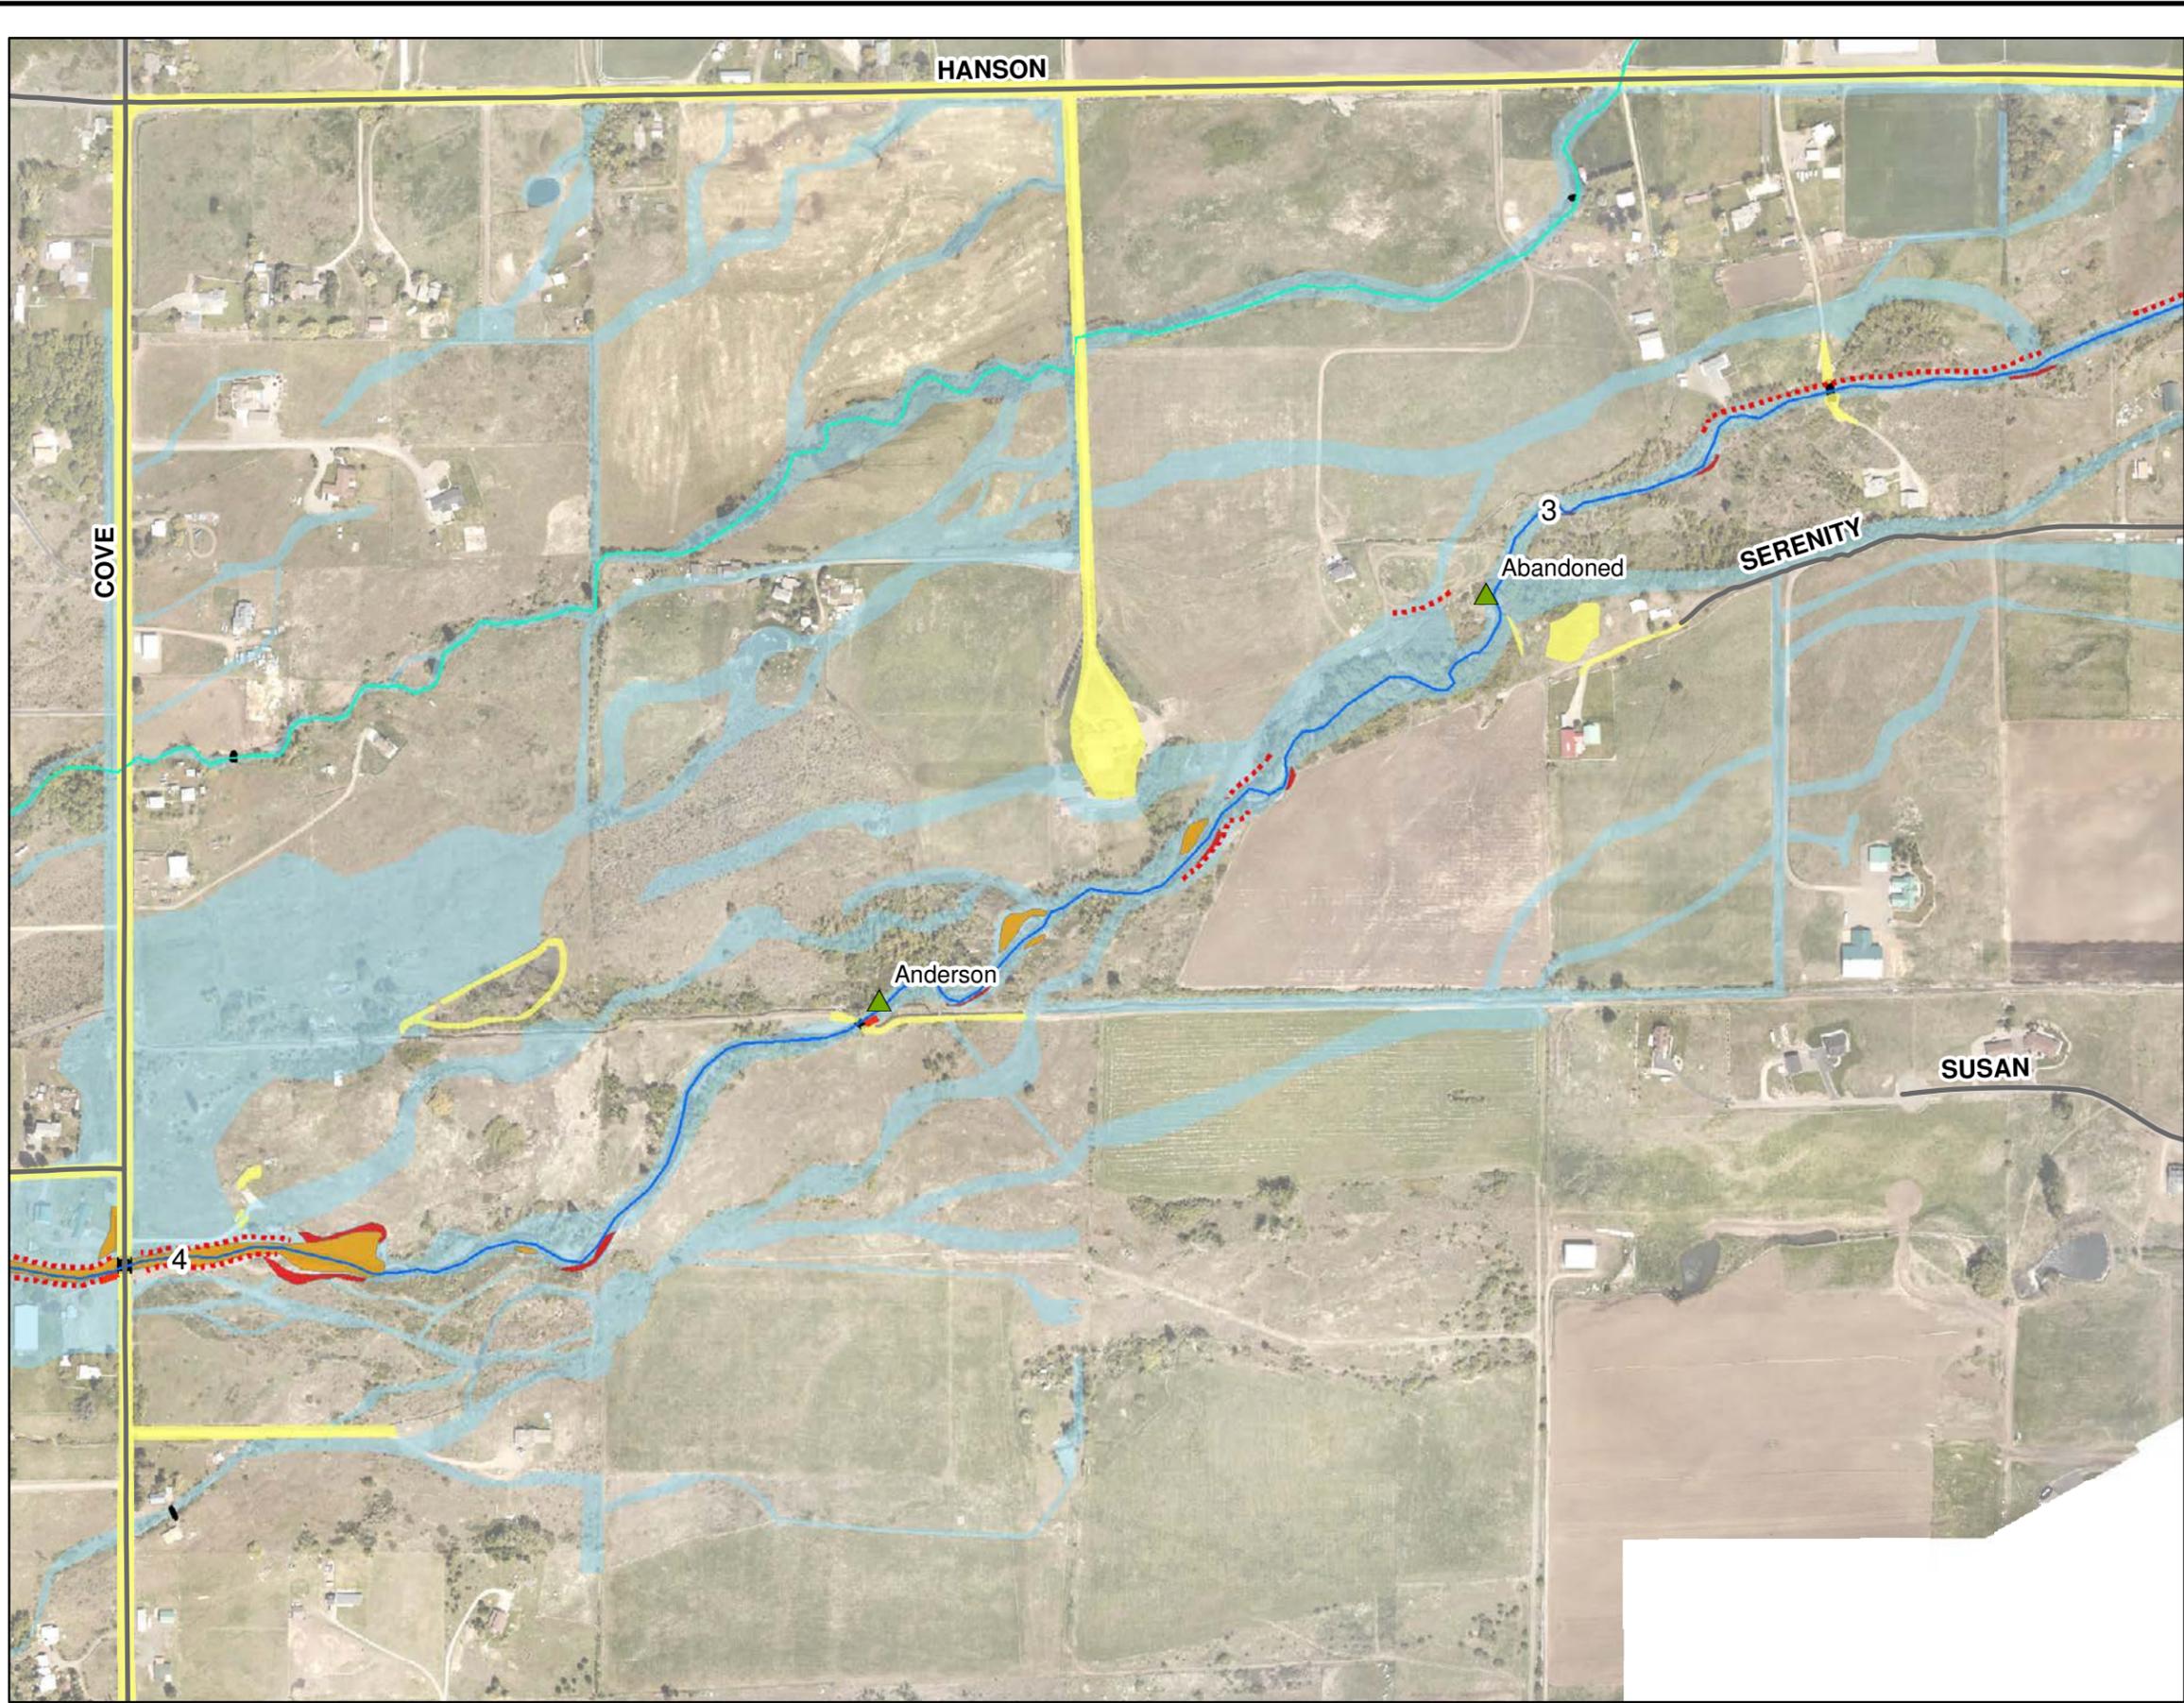
**Figure F6
Flood and Erosion Overview
Fan Contraction Reach**

- As noted previously, during the May 2011 flood, significant sediment deposition occurred in the vicinity of Cove Road, starting approximately 700 feet downstream and extending approximately 400 feet upstream from the bridge (see Figures F-6 through F-9). This reduced channel capacity and clogged the Cove Road Bridge waterway, causing severe overbank flooding (Photos 5FC and 1FE).

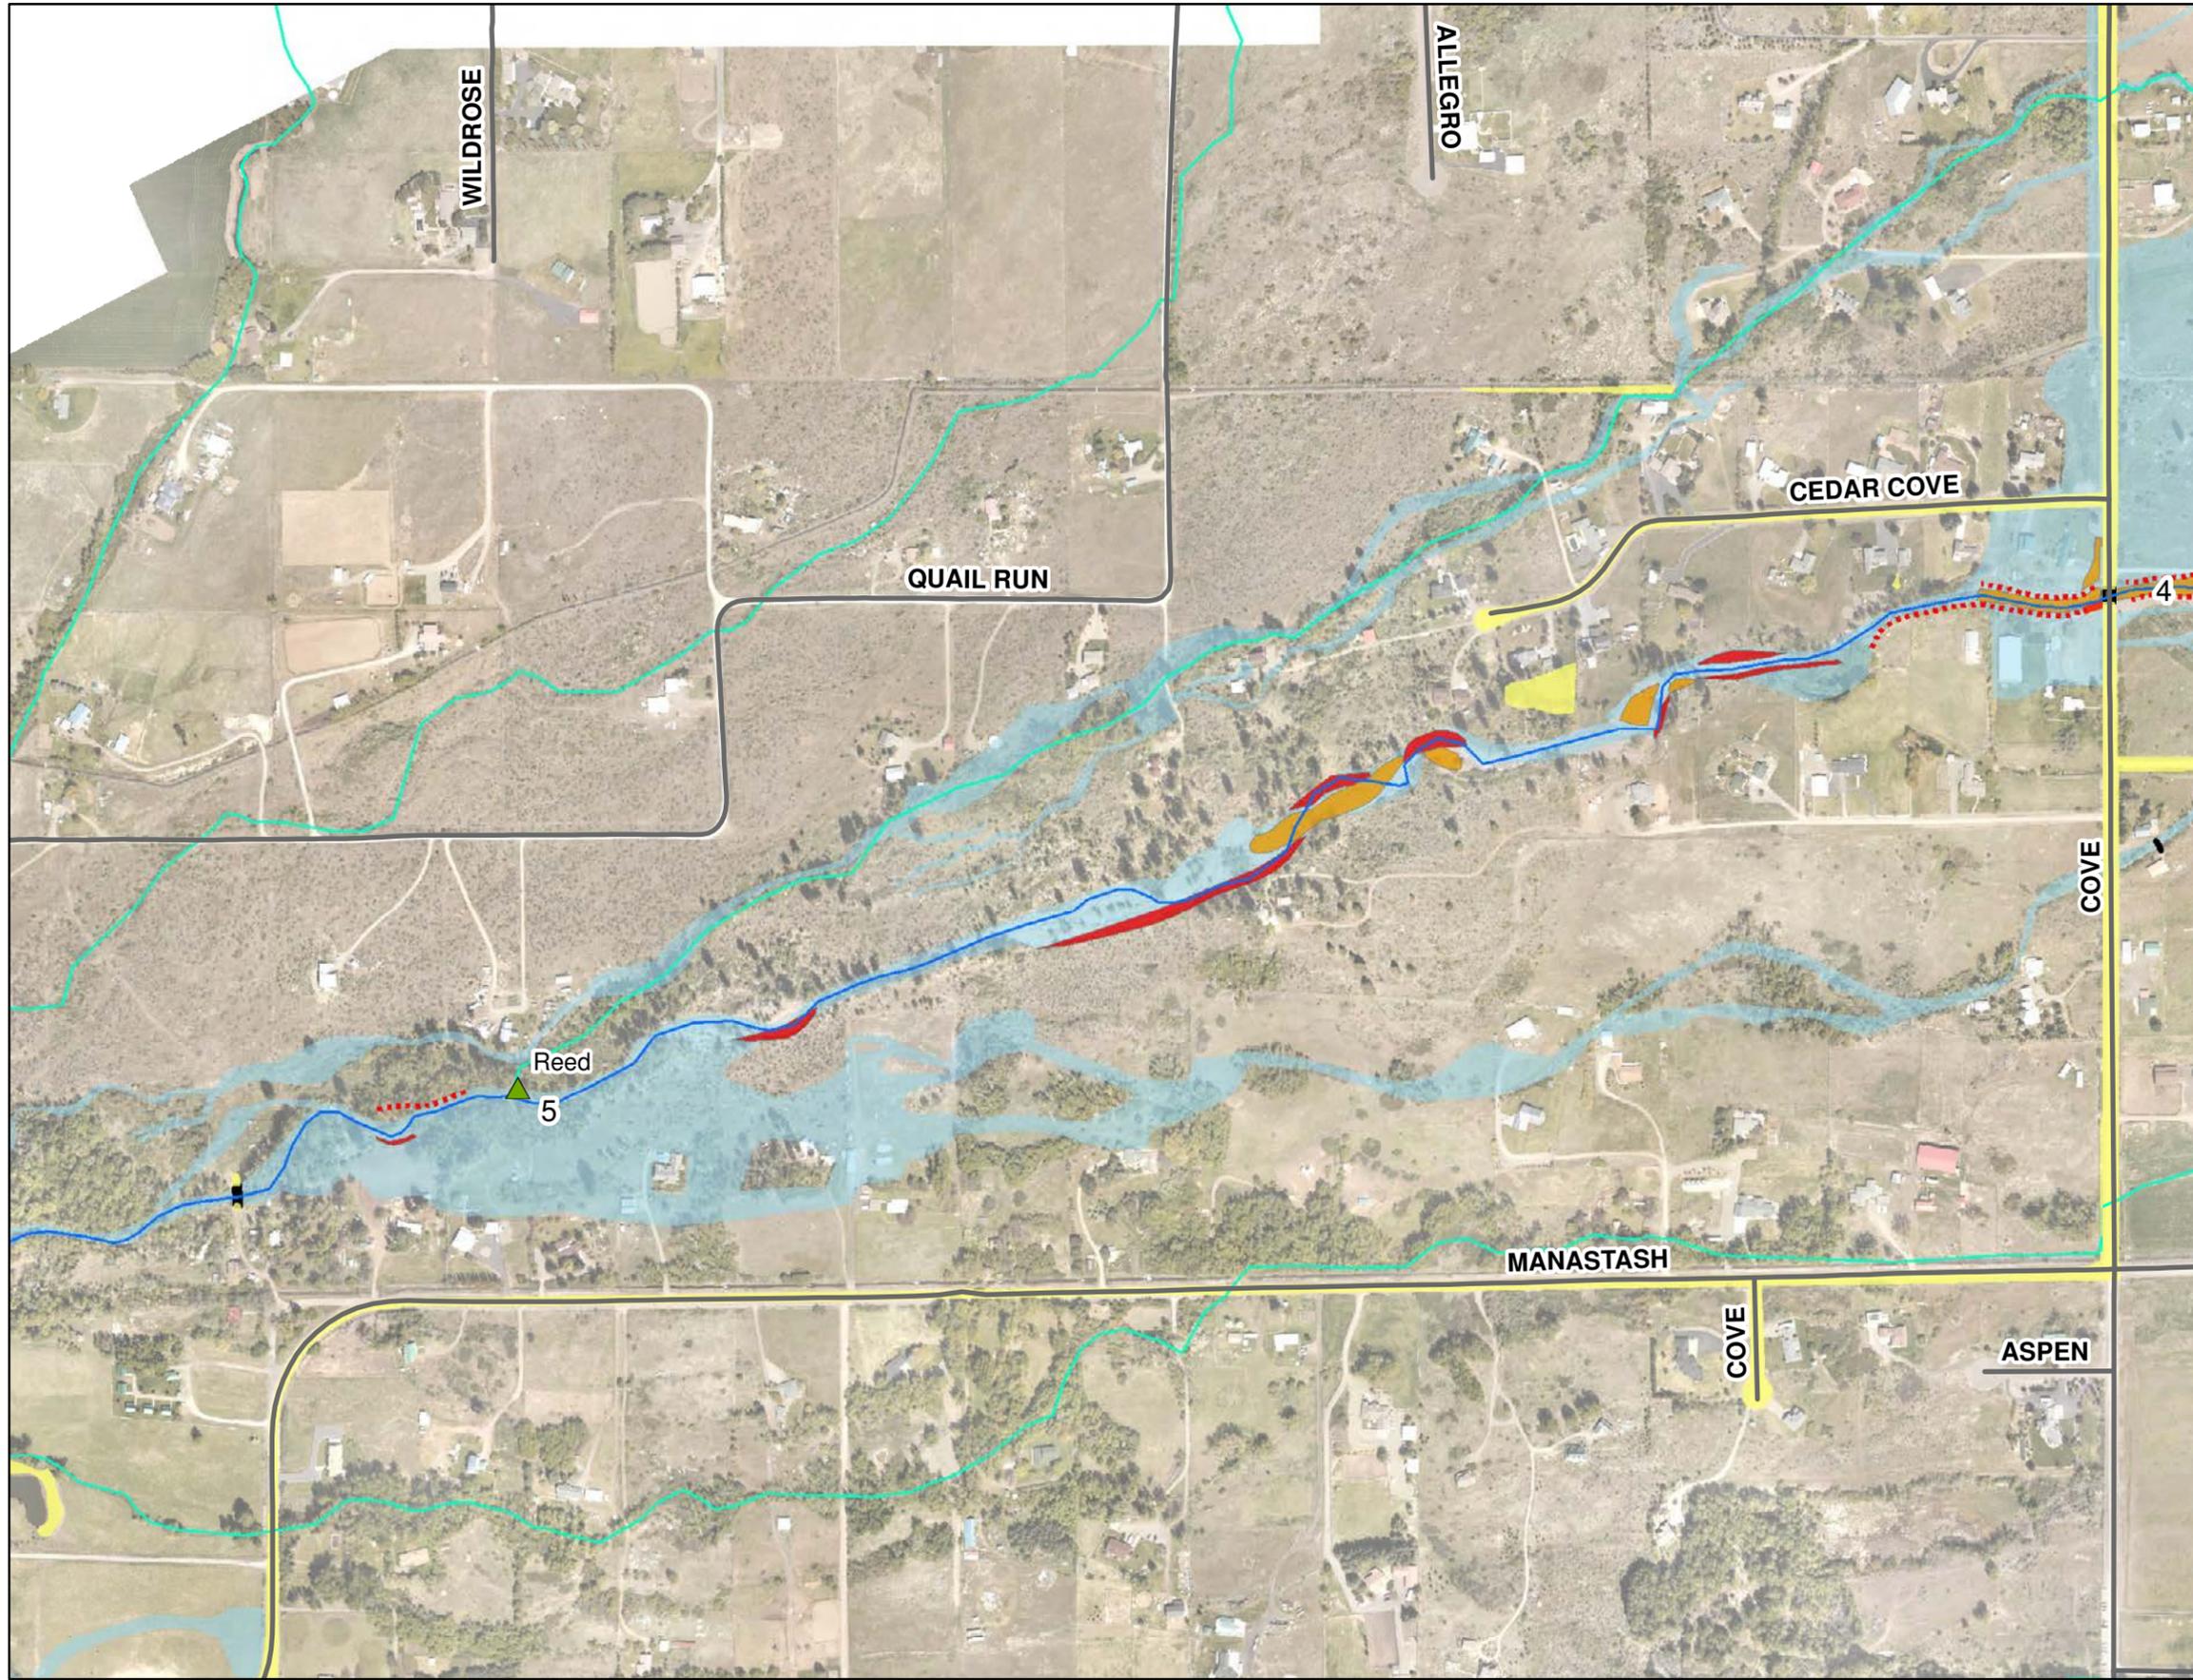
Figure F8
Flood and Erosion Overview
Fan Expansion Reach

- Extending approximately 1,000 feet upstream from the Reed Ditch diversion, sediment has deposited in and reduced the capacity of the stream channel. This was a major contributor to significant flow overtopping the right (south) bank during the May 2011 flood (Figures F-8 and F-9 and Photo 4FE).
- Numerous historical swales connect to and diverge from the stream channel along the Fan Expansion Reach (Figures F-9 and F-1). Some of the swales represent possible avulsion pathways.

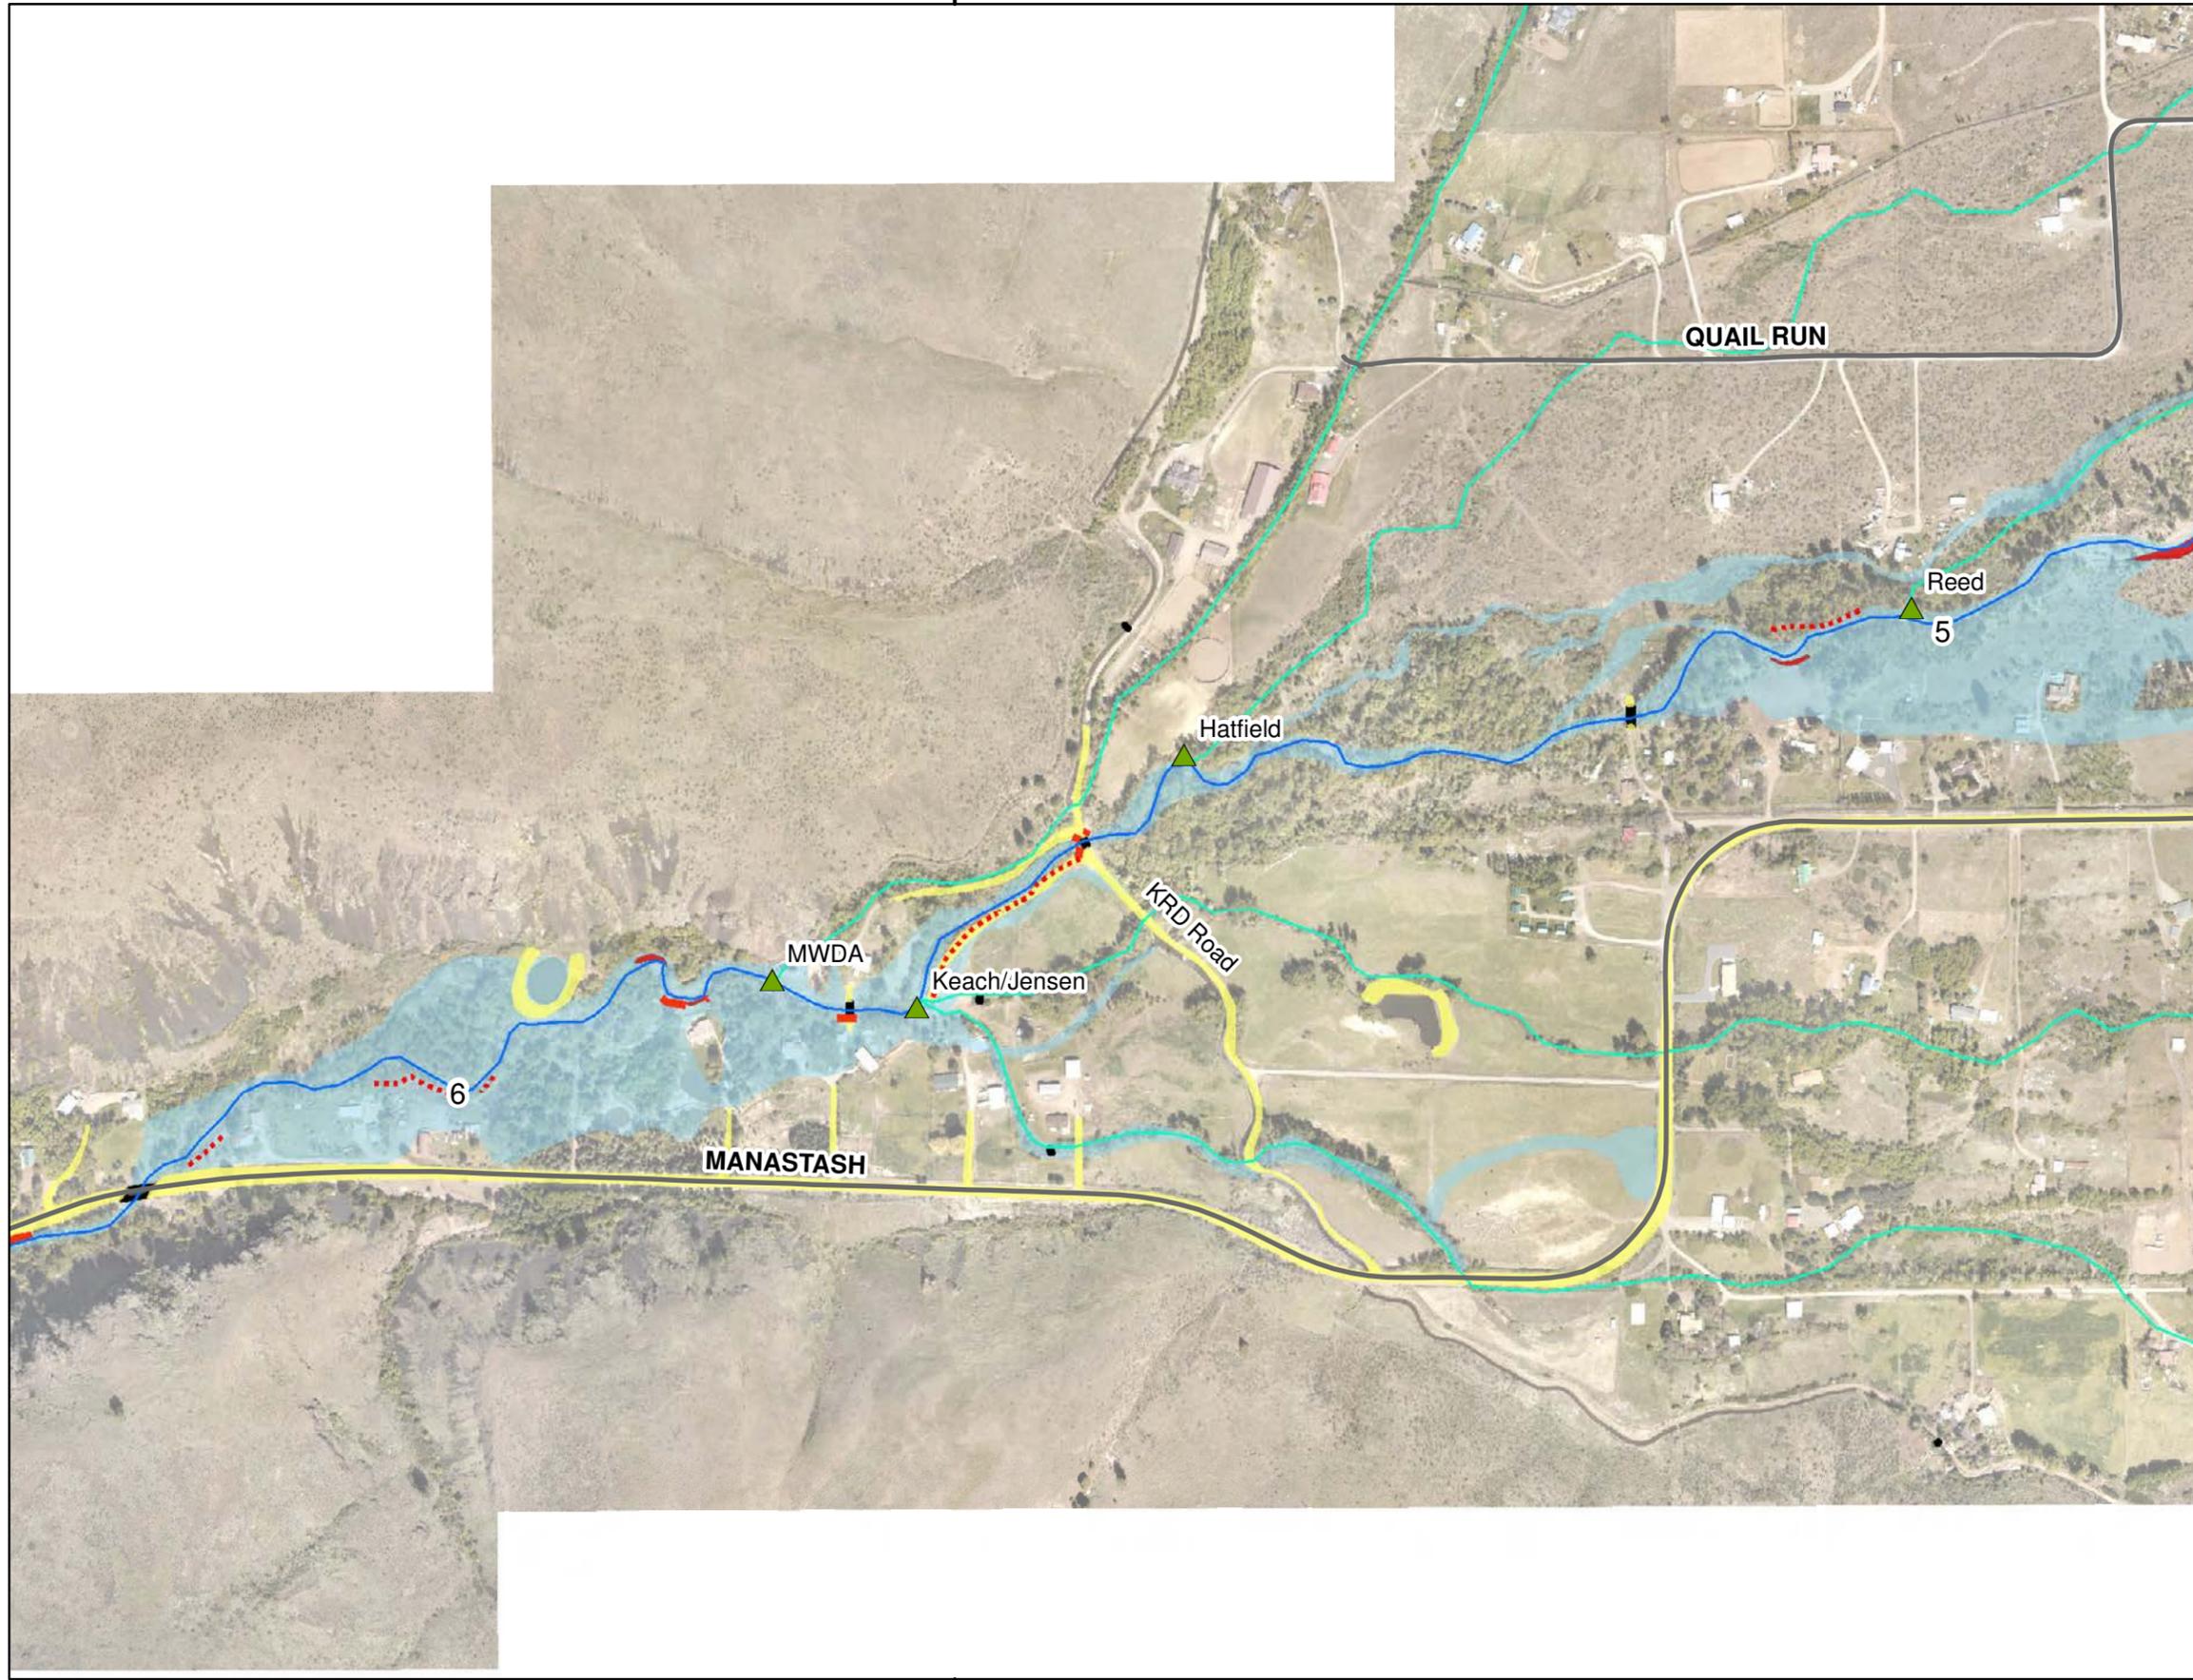
Figure F10
Flood and Erosion Overview
Canyon and Fan
Expansion Reaches

caused by the May 2011 flood are included in Appendix G (Photos 1C to 7C). Figures F-10 through F-23 show approximate areas of inundation and channel adjustment, including bank erosion and sediment deposition caused by the May 2011 flood. Streambed surface material pebble counts were completed in an abandoned meander bend at approximately RM 6.4 (see Photo 5C).

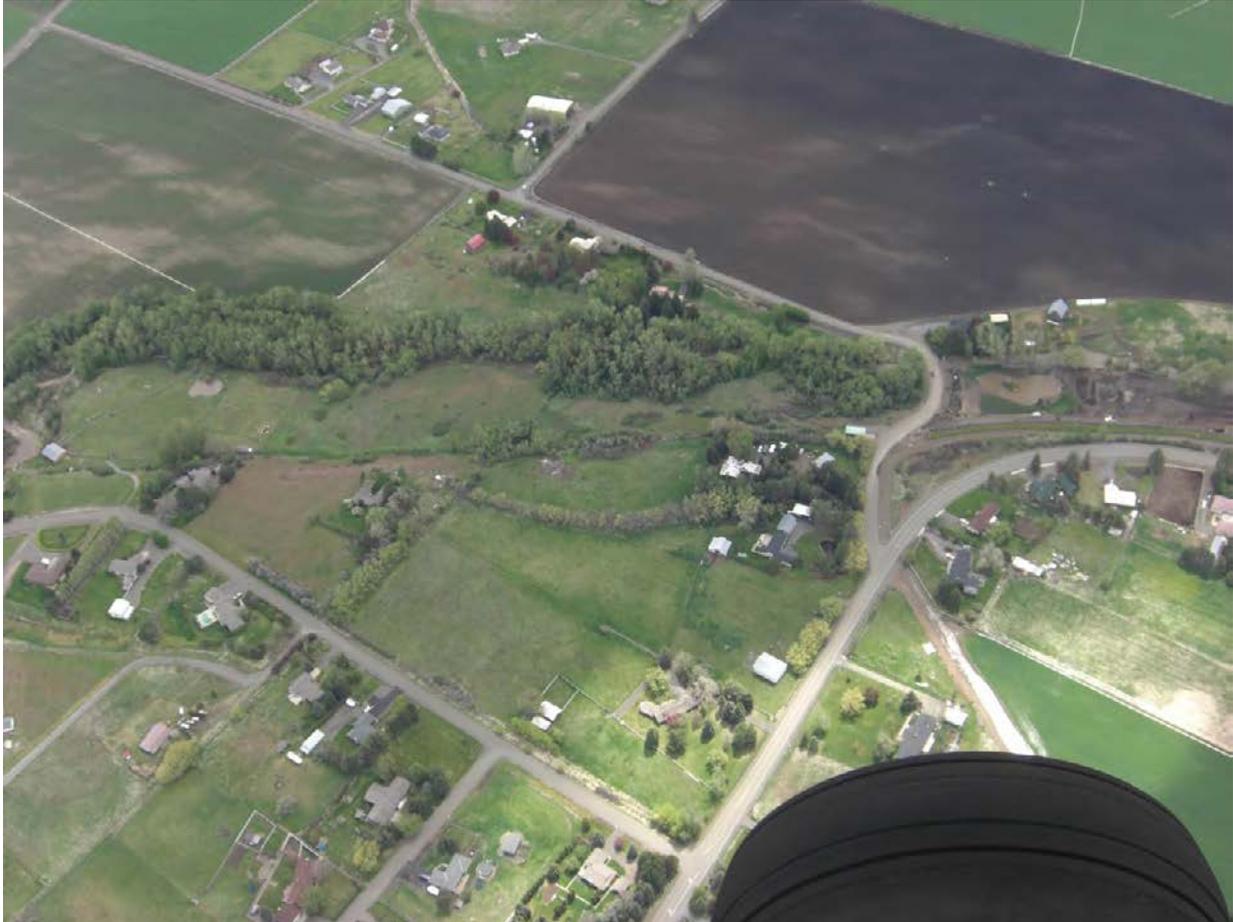
Photo 1ET. Viewing south over Manastash Creek at Barnes Road Bridge (right of center) during May 2011 flood. Water is generally confined within the treed corridor (County photo).

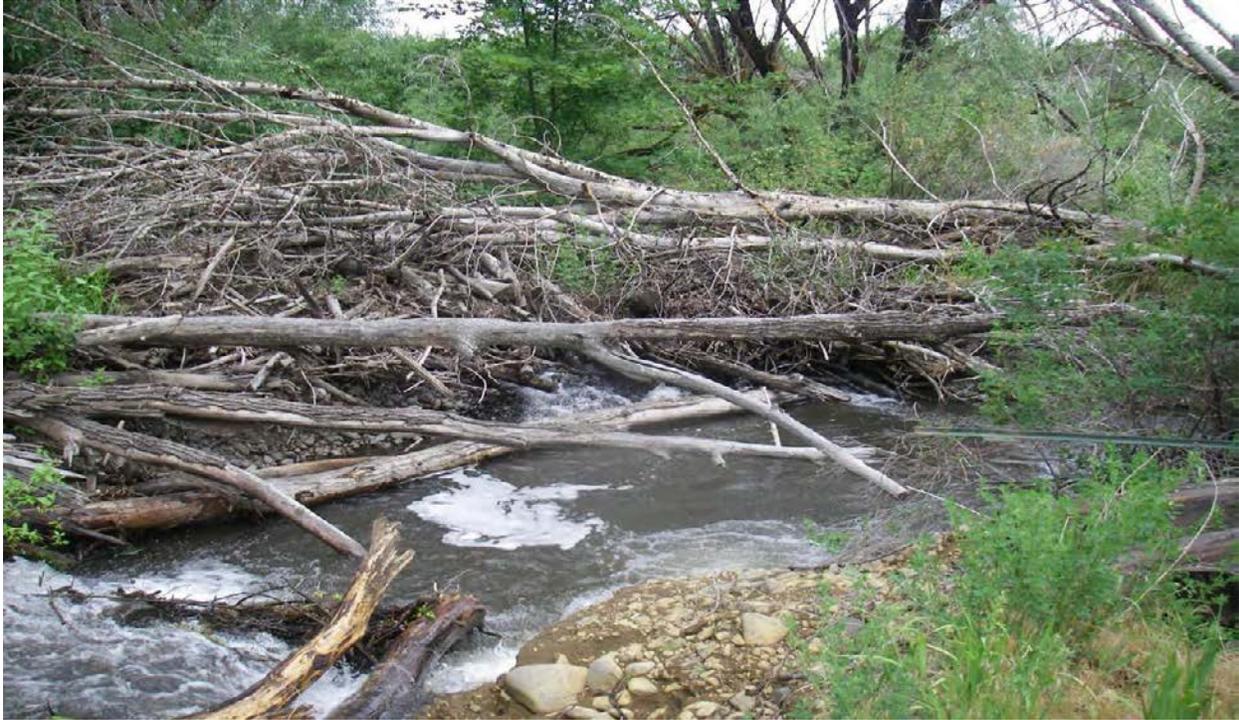
Photo 2ET. Example of debris jam within the entrenched reach.

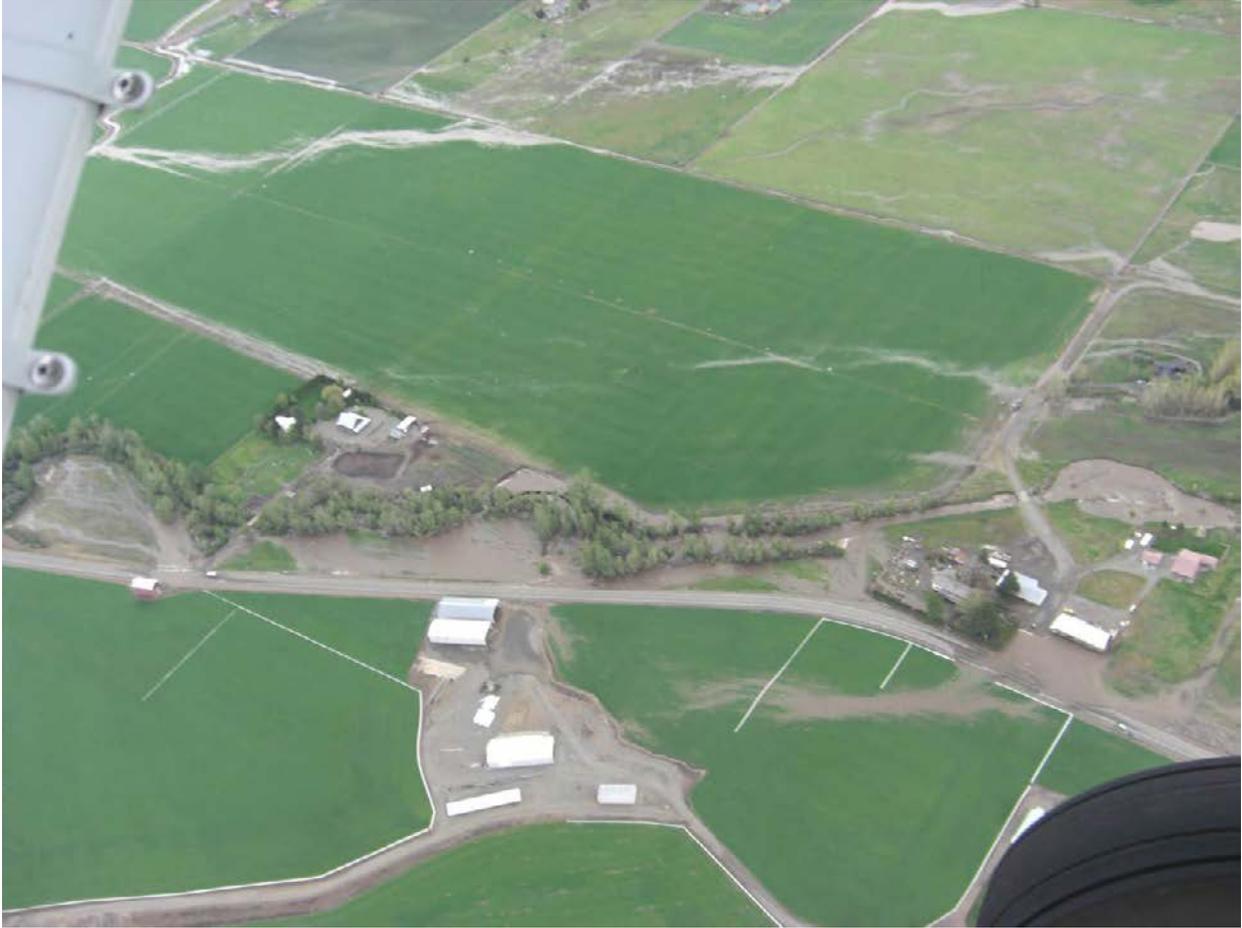
Photo 5ET. Viewing south to the entrenched reach during May 2011 flooding. The straight reach downstream of Serenty Lane (right center) carried sediment and wood which deposited in the inundated field and trees approximately 800 ft downstream (County photo).

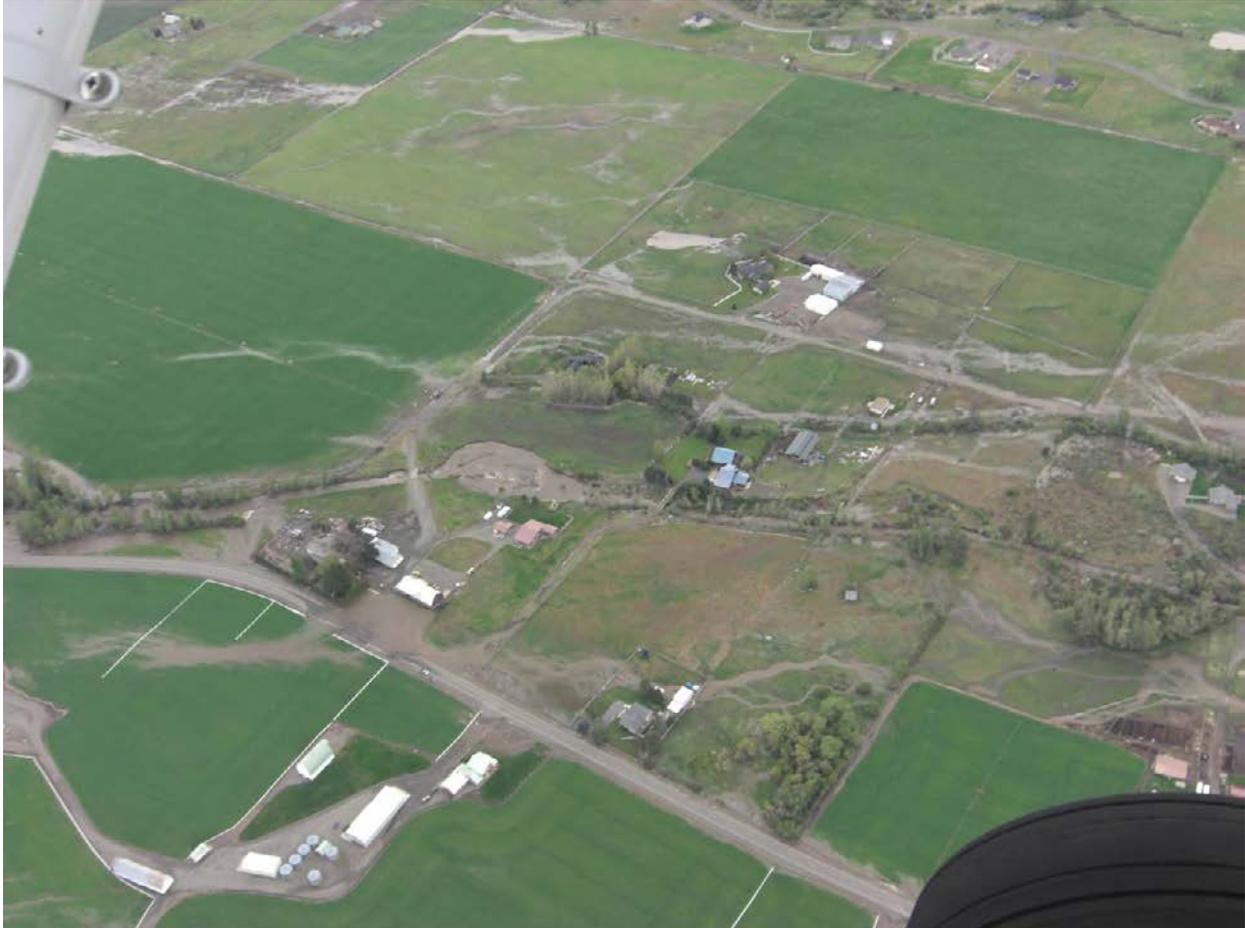
Photo 1FC. Viewing south to flowpaths converging at Serenity Lane bridge (left of center) during May 2011 Flood. Hanson Road, in foreground, intercepted a significant portion of overbank flow and funneled it back to the creek at this location (County photo).

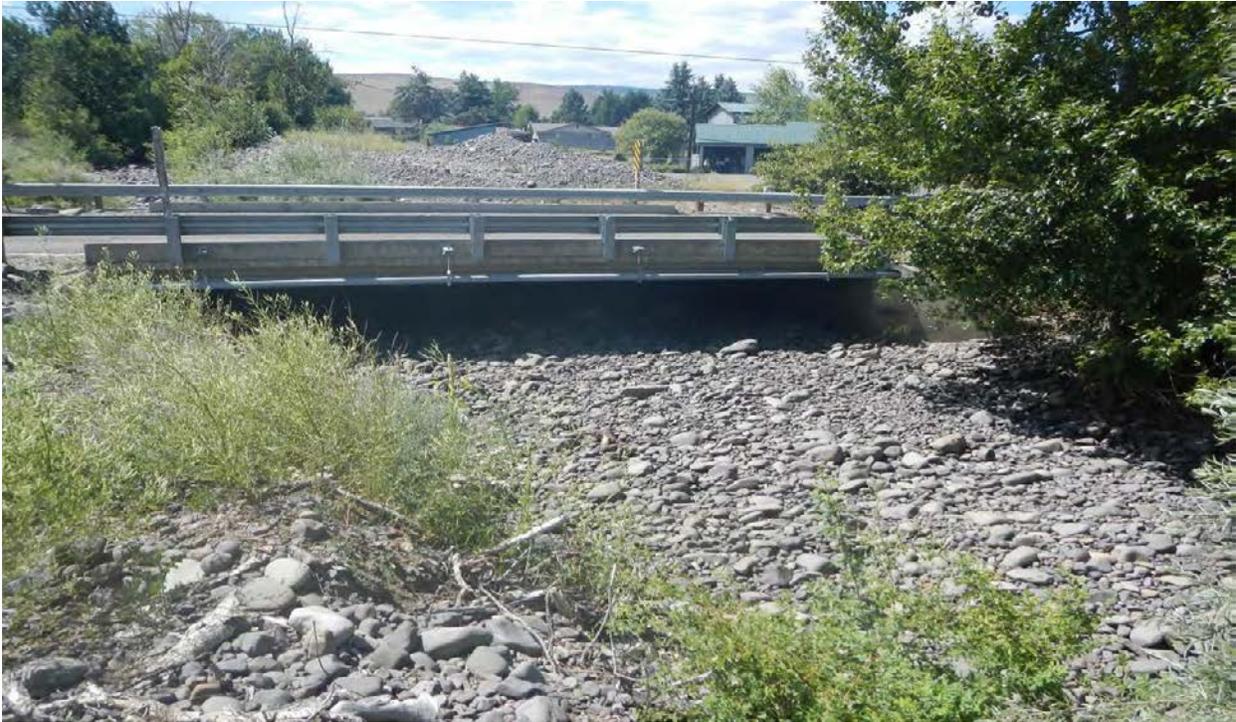
Photo 4FC. Viewing upstream (west) to Cove Road Bridge (July 25, 2012).

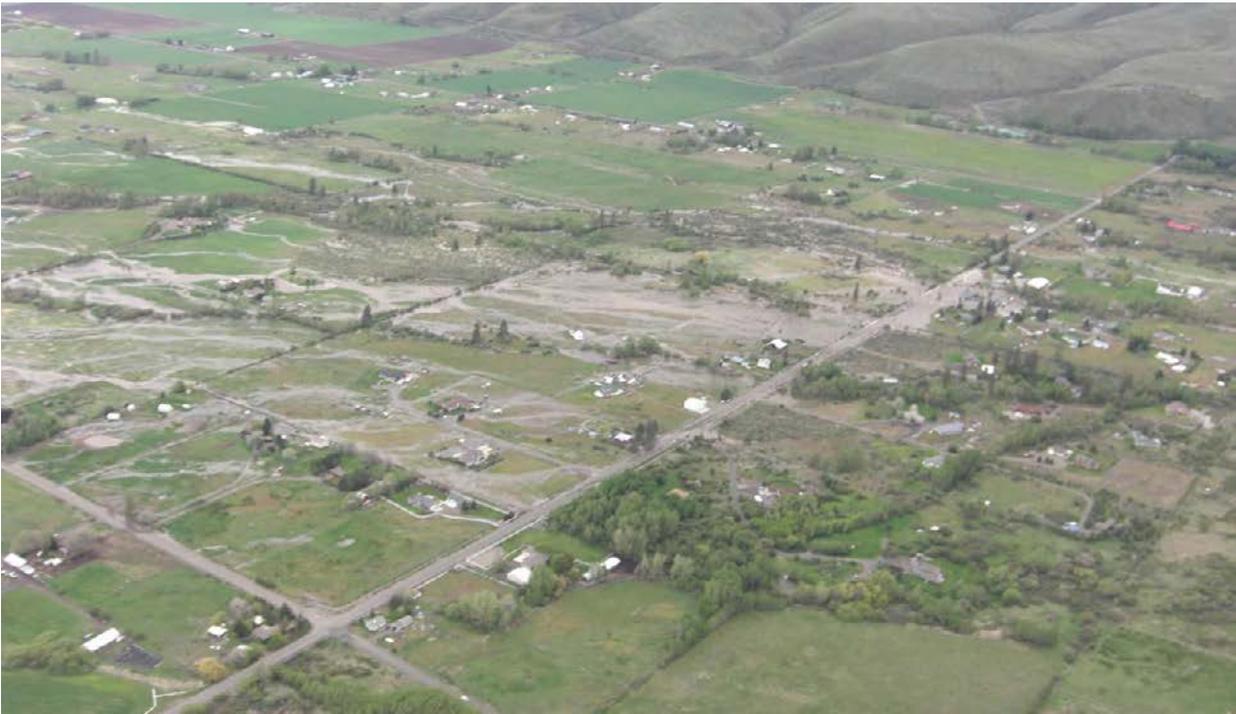
- Floodwaters that left the stream channel at Cove Road made their way downstream by following numerous historical swales and irrigation ditches (see Photo 5FC). Due to years of agricultural cultivation, many of the historical swales are difficult to distinguish; therefore, some local landowners were surprised when flow entered their property.
- Relatively minor lateral erosion and sediment deposition occurred at a number of other sites along the reach (see Figures F-4 through F-7).

Photo 5FC. Flow escaping the channel at Cove Road during May 2011 flooding. Historical floodplain swales are highlighted by water working its way down the fan (County photo).

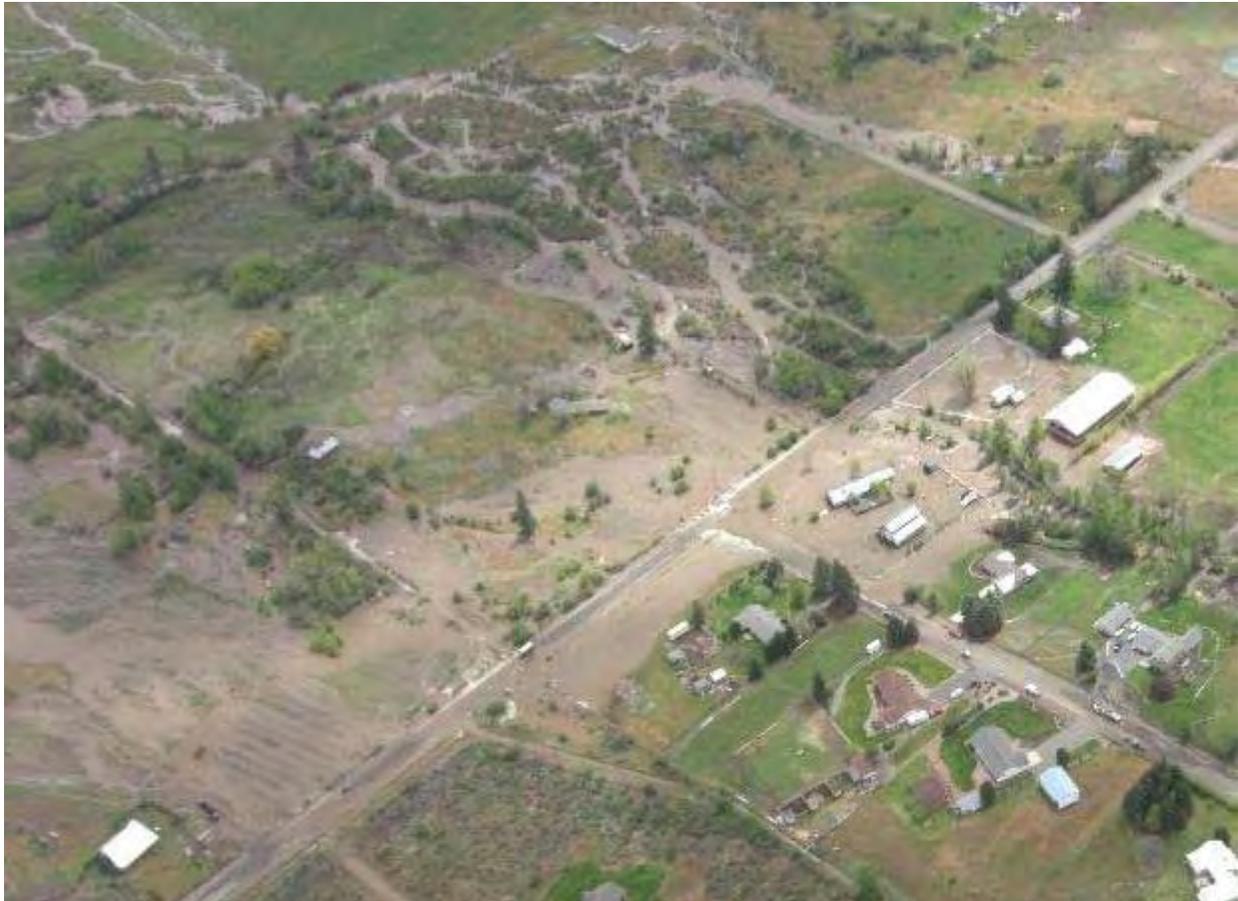
Photo 1FE. Flooding at Cove Road during May 2011 flooding (County photo).

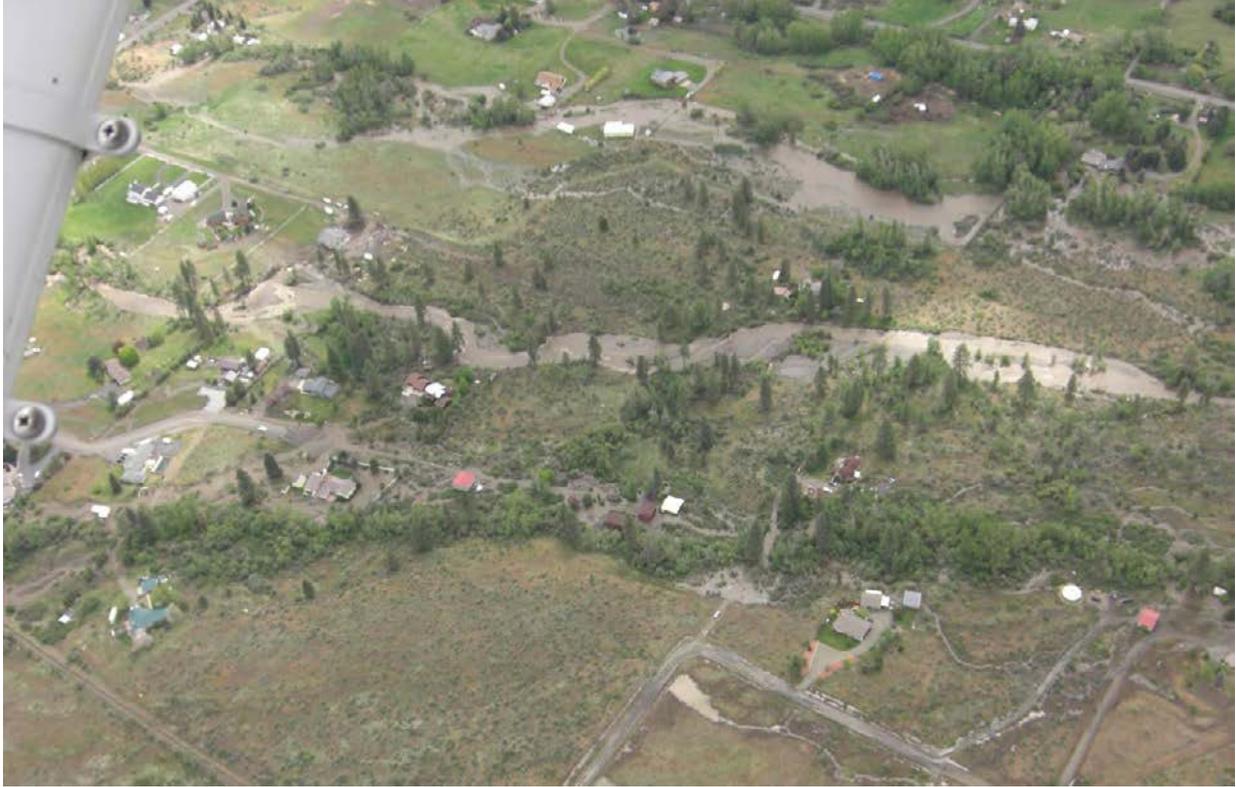
Photo 2FE. Viewing south over Quail Run and Cedar Cove Roads during May 2011 Flooding. Scour and deposition occurred within the main channel (center), and flow has entered the Reed Ditch (foreground) and an overflow path south of the creek (background) (County Photo).

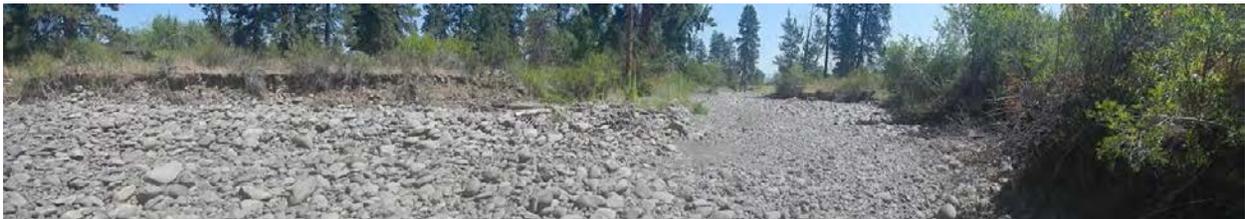
- In many locations, the streambed is covered by boulders, many of which are too large to be moved a significant distance by the stream (Photo 3FE). The boulders are exposed in eroded stream banks and are glacial drift outwash, not stream alluvium (Photo 5FE).

Photo 3FE. Scoured channel bank along Carns Property near RM 4.4. Notice change in gradation between material near the bank and within the channel Photo taken July 26, 2012 during sediment sampling. Weak creekside vegetation allowed significant bank erosion within this reach.

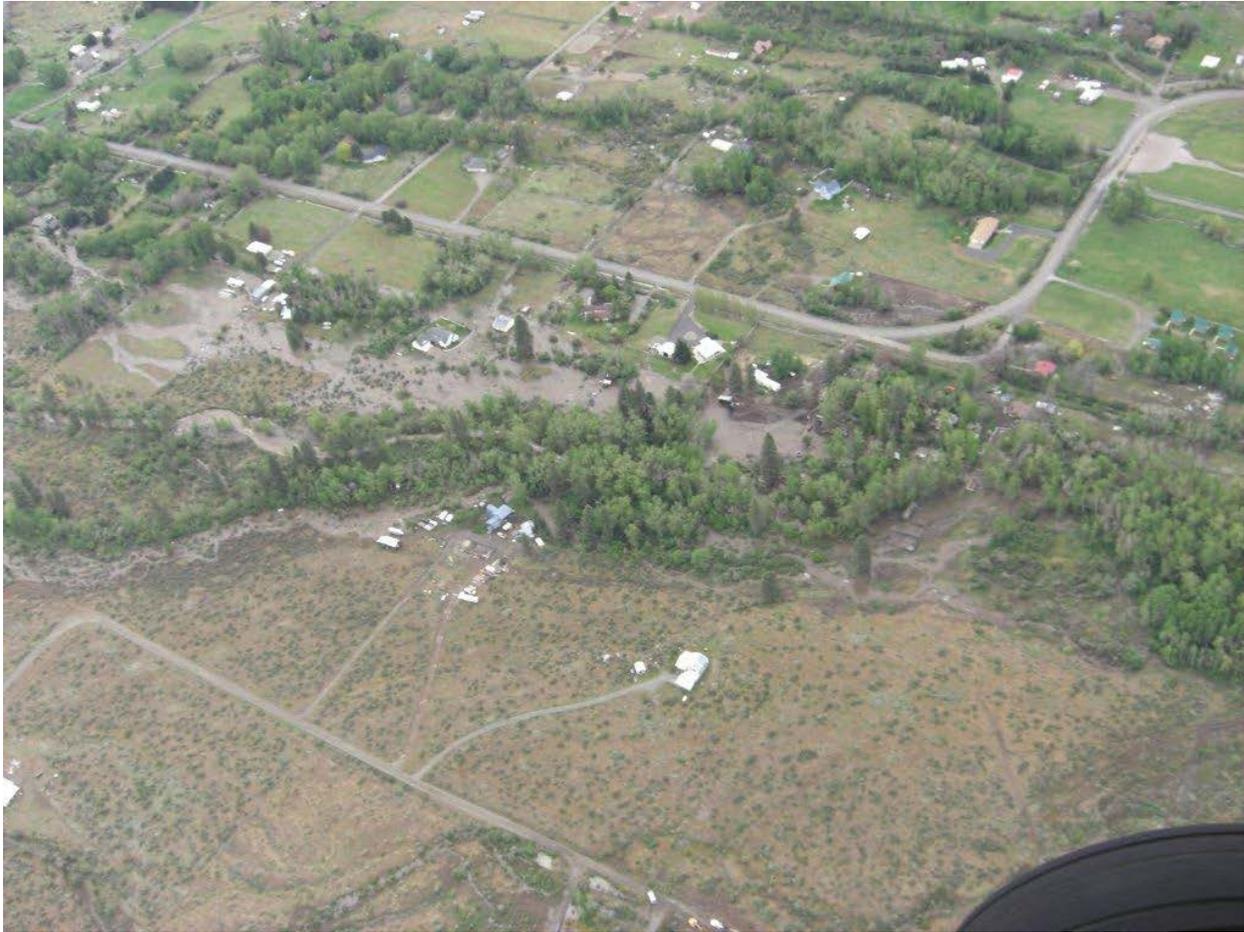
Photo 4FE. Viewing south in the vicinity of the Reed Diversion Dam during May 2011 Flooding. The stream is in the middle of the treed corridor. Flow has entered the Reed Ditch (foreground) and the south floodplain (background) (County Photo).

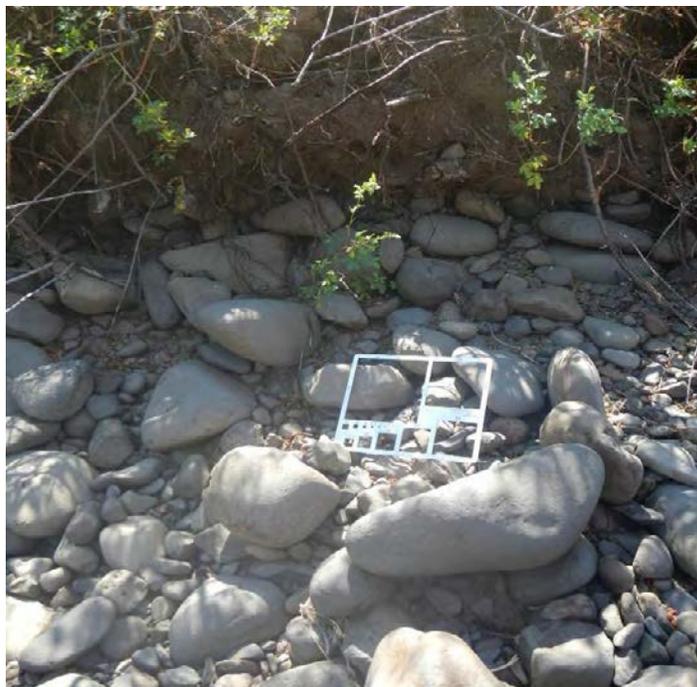
Photo 5FE. Large material eroded from the channel bank on the Carns property (July 25, 2012). This is glacial drift outwash and many of the stones are too large to be transported downstream.
