WATERSHED AND REACH SCALE INVESTIGATION OF EXISTING CONDITIONS

MANASTASH CREEK CORRIDOR HABITAT ENHANCEMENT AND FLOOD HAZARD REDUCTION PLAN

Prepared for
Kittitas County Conservation District

November 1', 2012

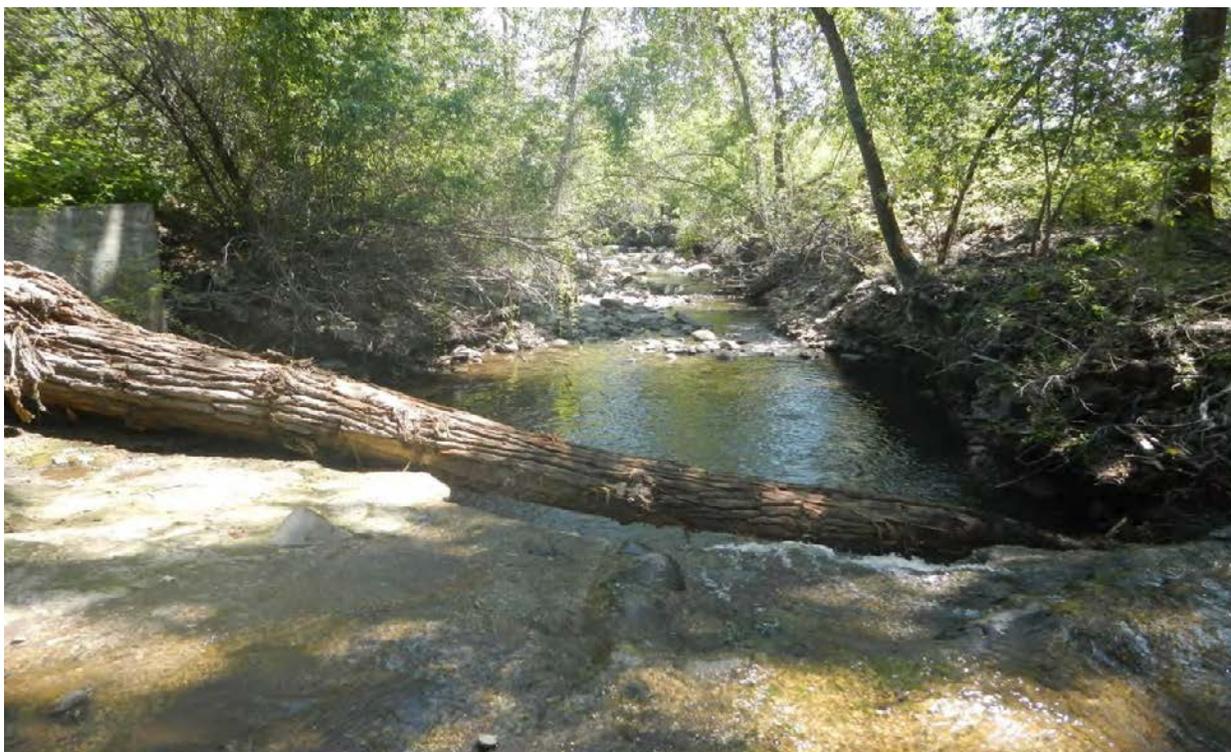
- A narrow and deeply entrenched reach begins at the Reed Ditch diversion and extends approximately 1,500 feet downstream (Photo 6FE). Due to this entrenchment, the

Photo 6FE. Viewing downstream to the incised reach below Reed Dam (July 25, 2012).

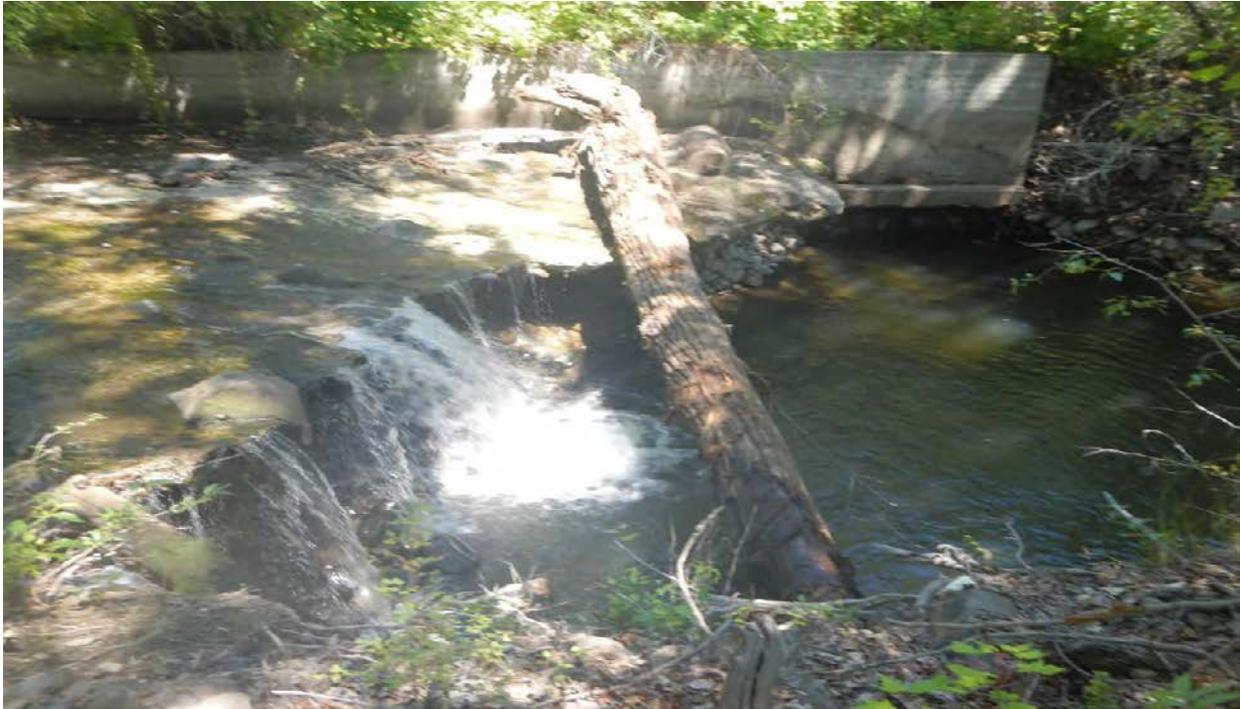
Reed Ditch diversion has been severely undermined and is perched approximately 10 feet above the bed of the downstream channel (Photo 7FE).

Photo 7FE. Water flowing over the dam at Reed Dam on July 25, 2012. Severe incision has resulted in erosion beneath the structure leaving the dam perched above the channel.

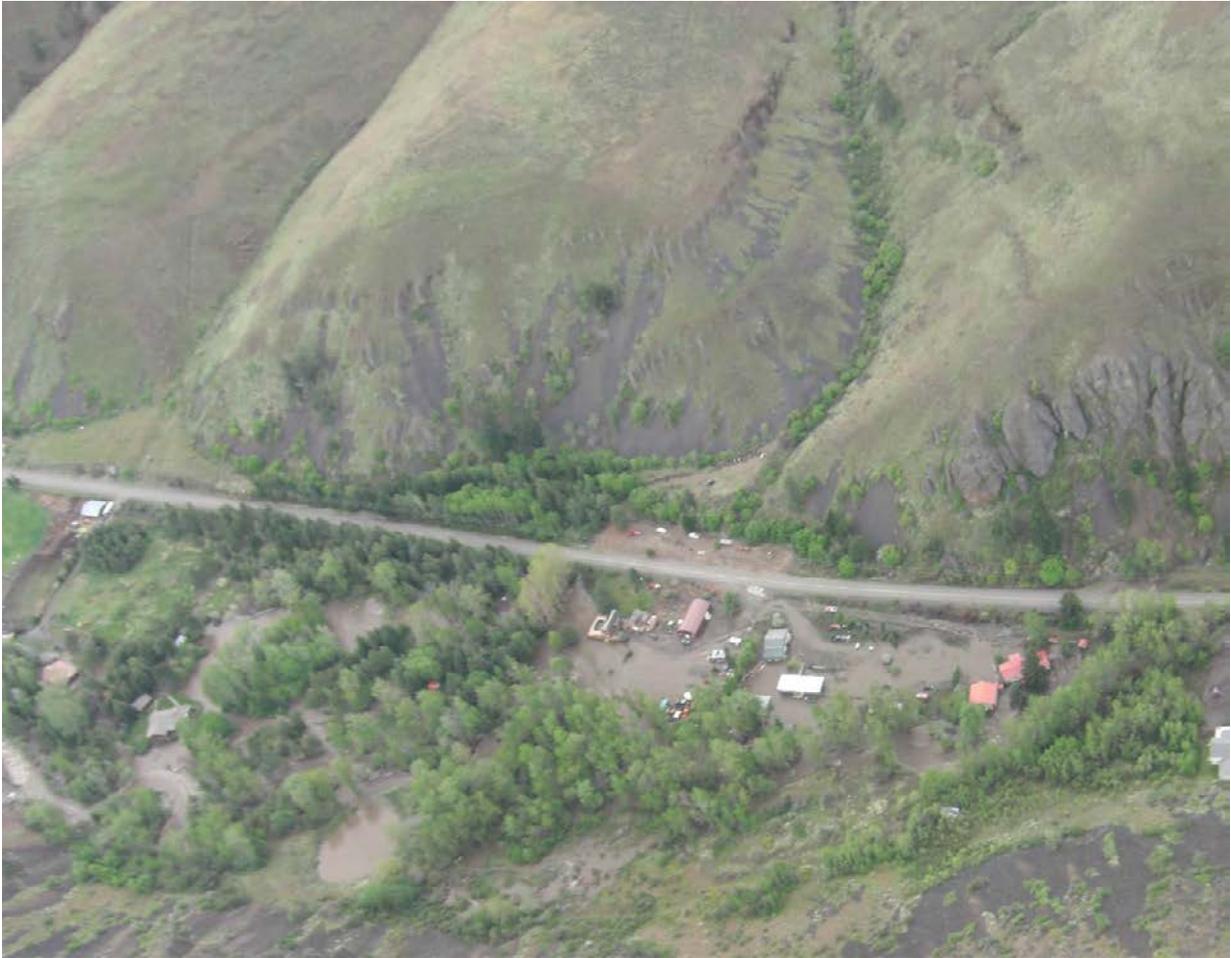
Photo 1C. Viewing south just upstream from the mouth of the canyon during the May 2011 flooding within the Sienia, Kinnan, Berger and Bradley properties (County Photo).

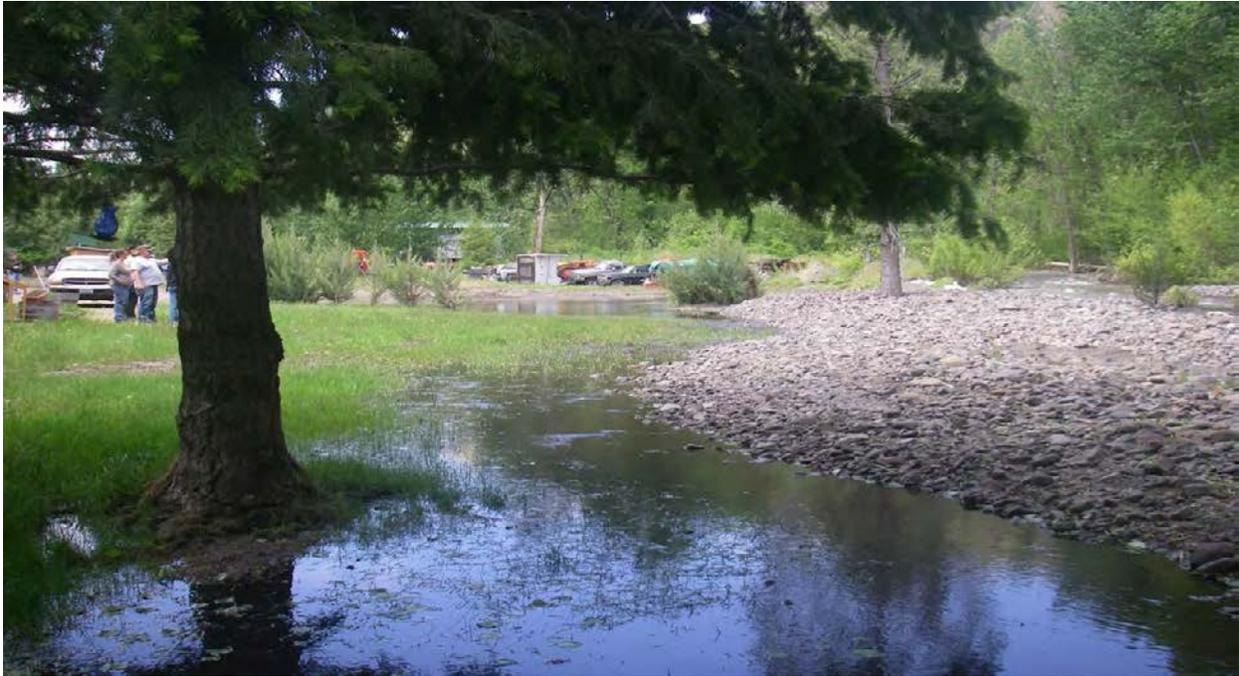
Photo 2C. Viewing upstream to overbank flooding on the Berger property which is near the mouth of the Canyon in the area shown in Photo 1C. The main channel is located to the right of the photo, and overflow water seen in the foreground continued down the valley floor to flood downstream landowners.

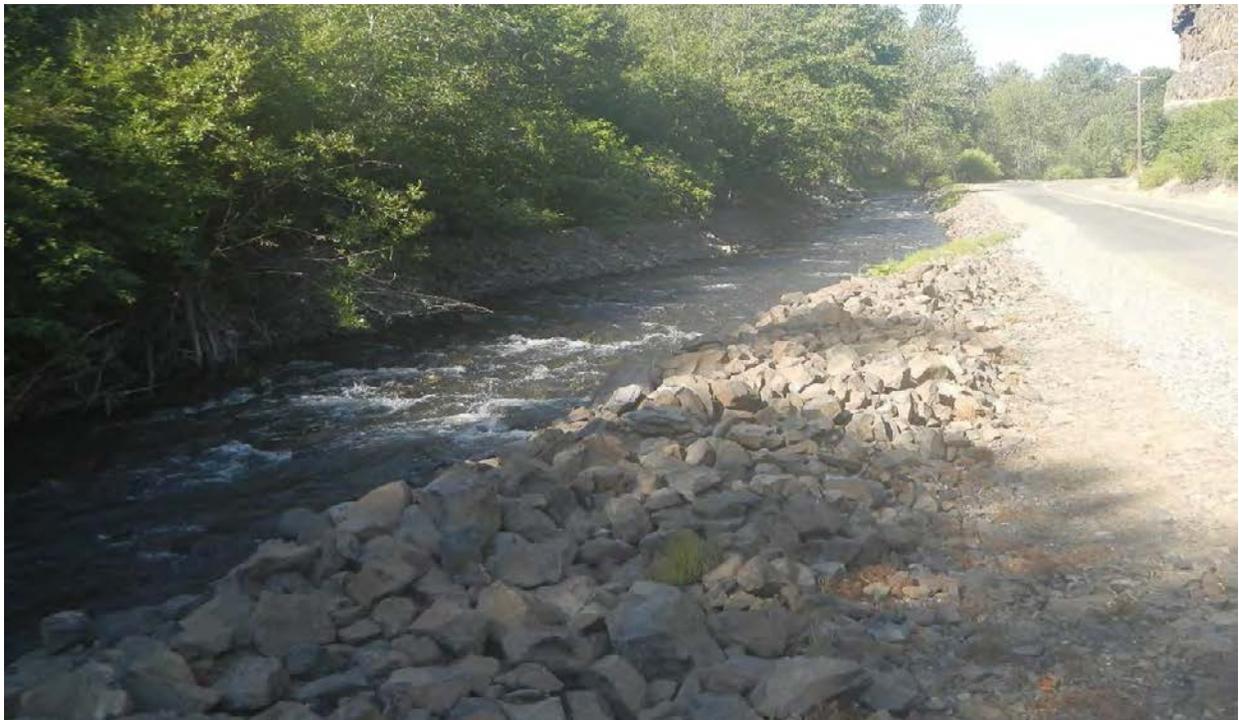
- Manastash Road is adjacent to the stream in several areas. The County has placed riprap in those areas to protect the road (Photo 3C).
- Manastash Road crosses over the North Fork of Manastash Creek immediately upstream of the confluence near RM 11.7. The crossing is a corrugated metal pipe (CMP) culvert, which did not have the capacity to pass the May 2011 North Fork flood. Floodwater bypassed the culvert and crossed the road to the east. The road sustained major erosion damage.
- The Keach Jensen and MWDA diversions are relatively new structures that are adjacent to the channel. At both diversions, a series of cross-channel weirs were installed to provide fish passage, grade control and to maintain predictable water levels for irrigation withdrawals. The intake facilities at both diversions were overtopped during the May 2011 flood (Photos 6C and 7C).

The stream channel generally maintains a natural meandering planform in the Canyon Reach. However, there are reaches that appear to have been straightened or moved in the past (see Photo 3C, which shows an area near RM 10).

Figure 3C. Straightened channel along Manastash Road within the canyon reach near River Mile 10. Note riprap placed to protect road. Photo taken July 25, 2012.

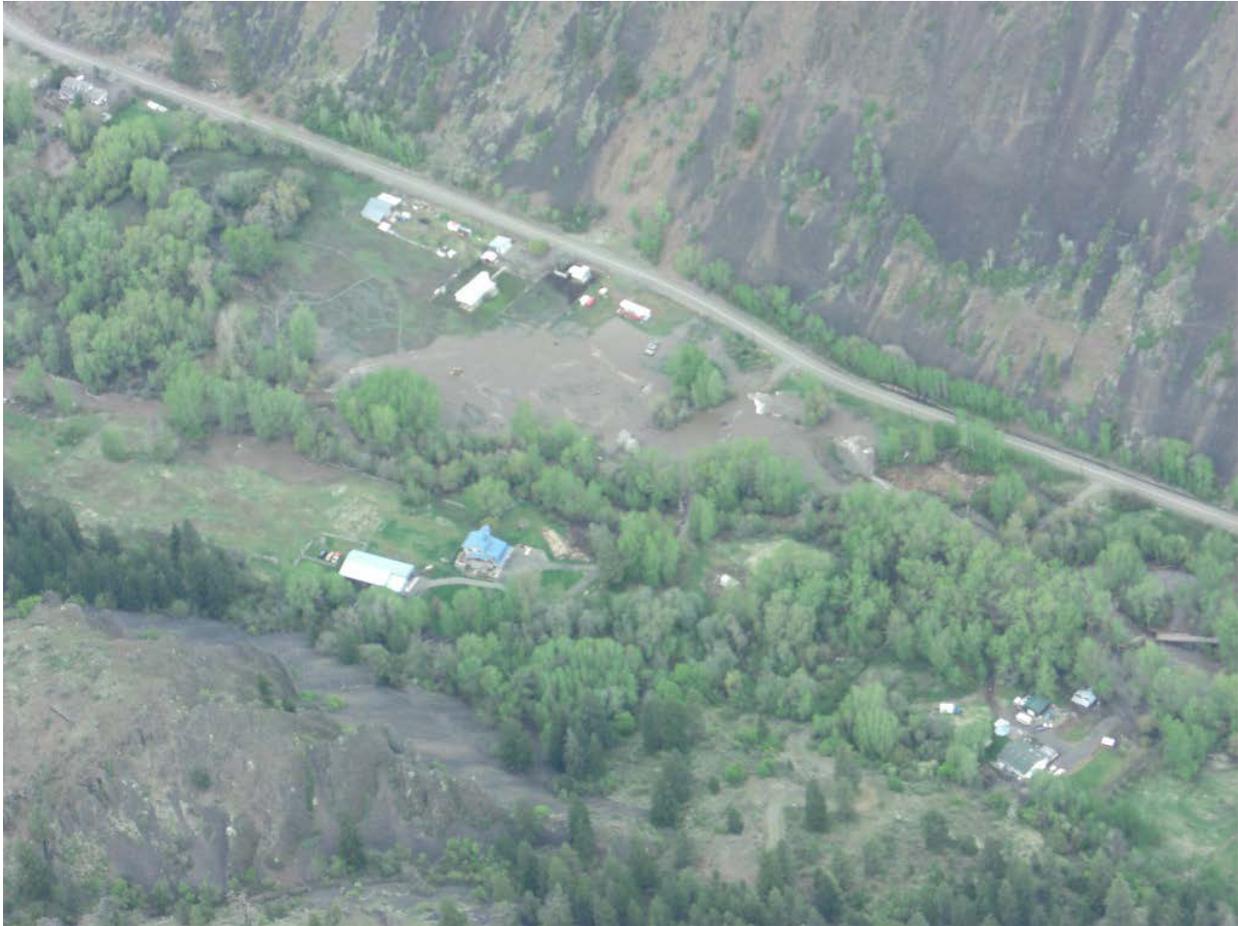
Figure 4 C. Viewing creek overflow/avulsion through Bauman property during the May 2011 flood. The head of this overflow path was later manually blocked by a berm constructed using sediment deposited on the Bauman property (County Photo).

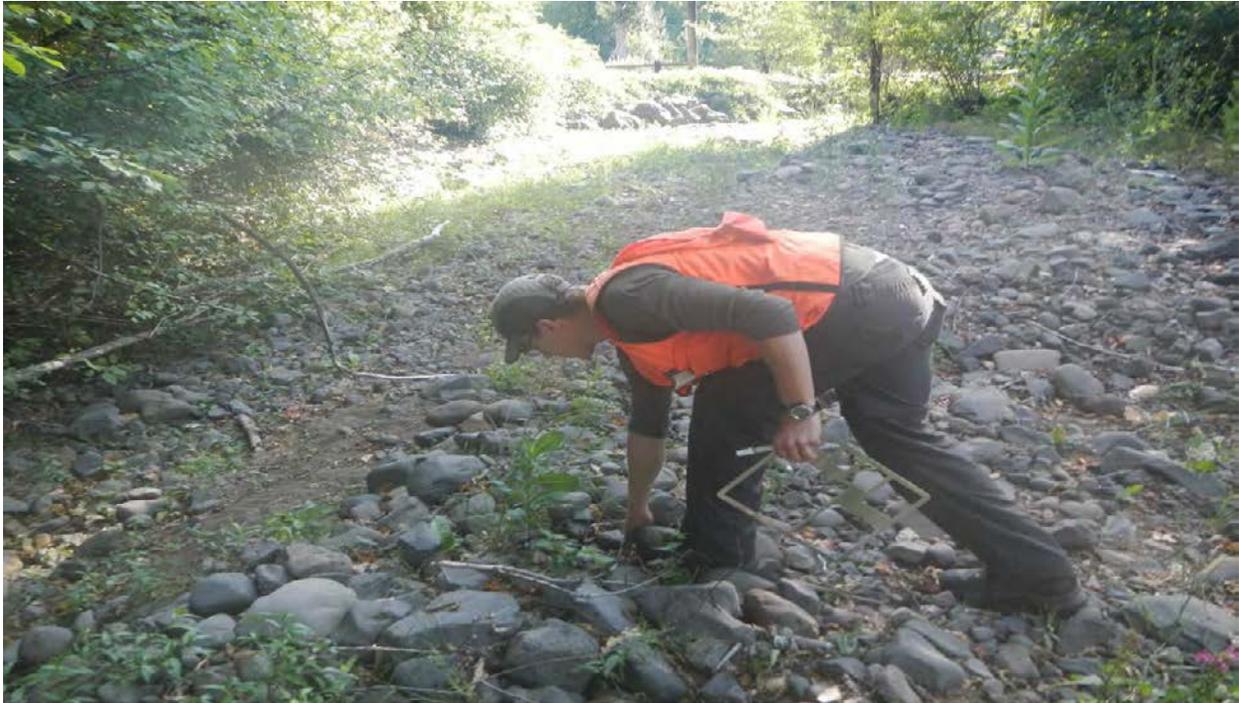
Figure 5C. Conducting a pebble count on an abandoned meander bend along the Cayon Reach approximately RM 6.4 (July 26, 2012).

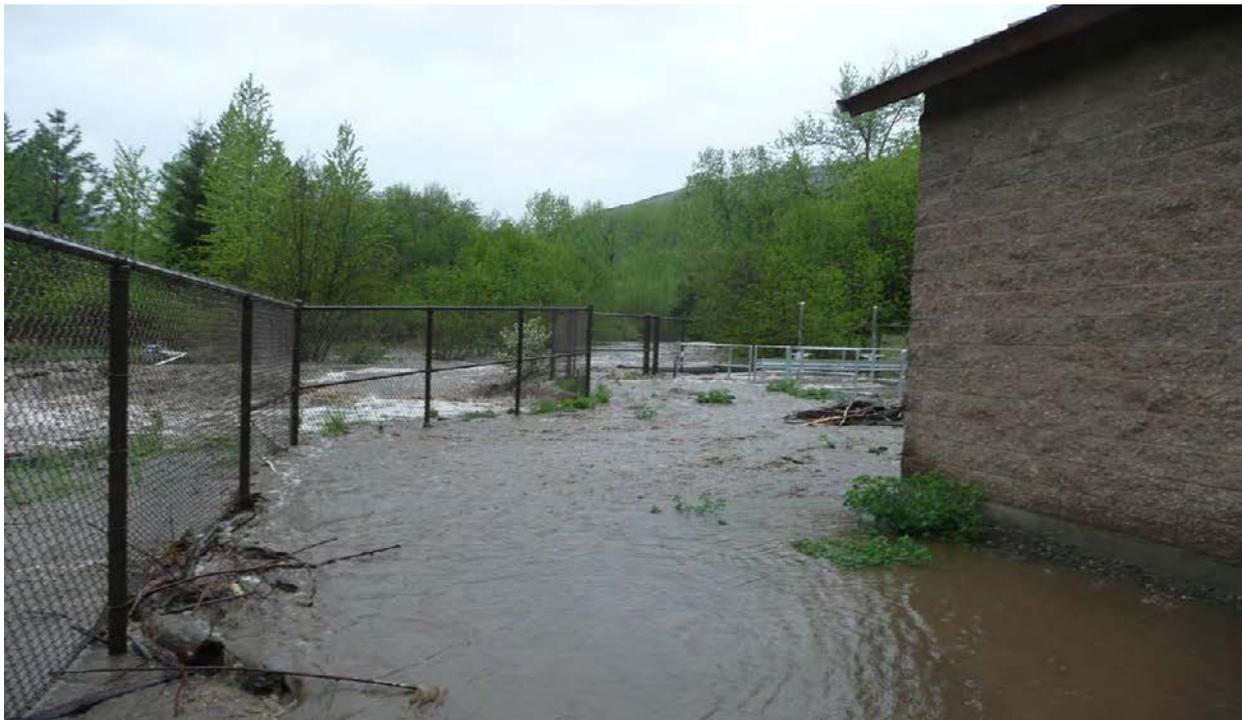
Figure 6C. MWDA diversion fooking upstream during May 2011 flooding (KCCD photo).

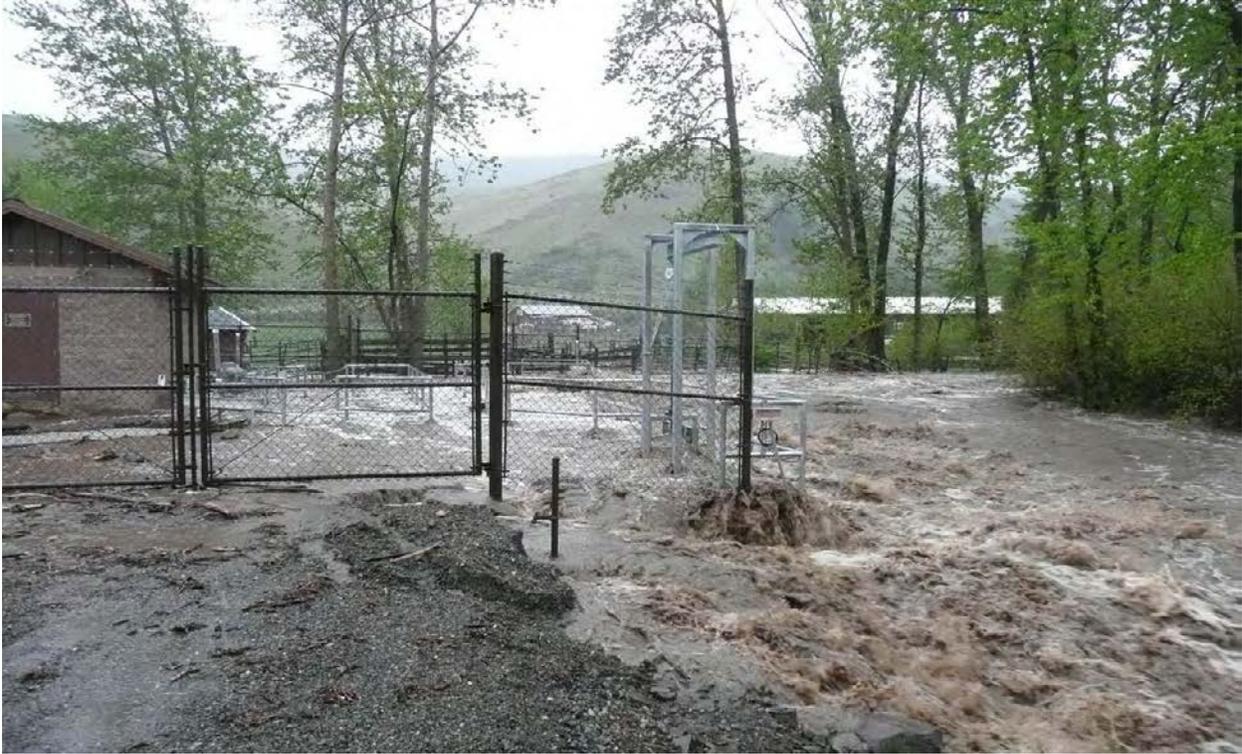
Figure 7C. Water overflowing the Keach-Jensen diversion during May 2011 flooding (KCCD photo).
