Driveway Bridges

Reach 14
Canyon 14 (3 of 3 Figures)
(RM 6.85 to RM 8.9)

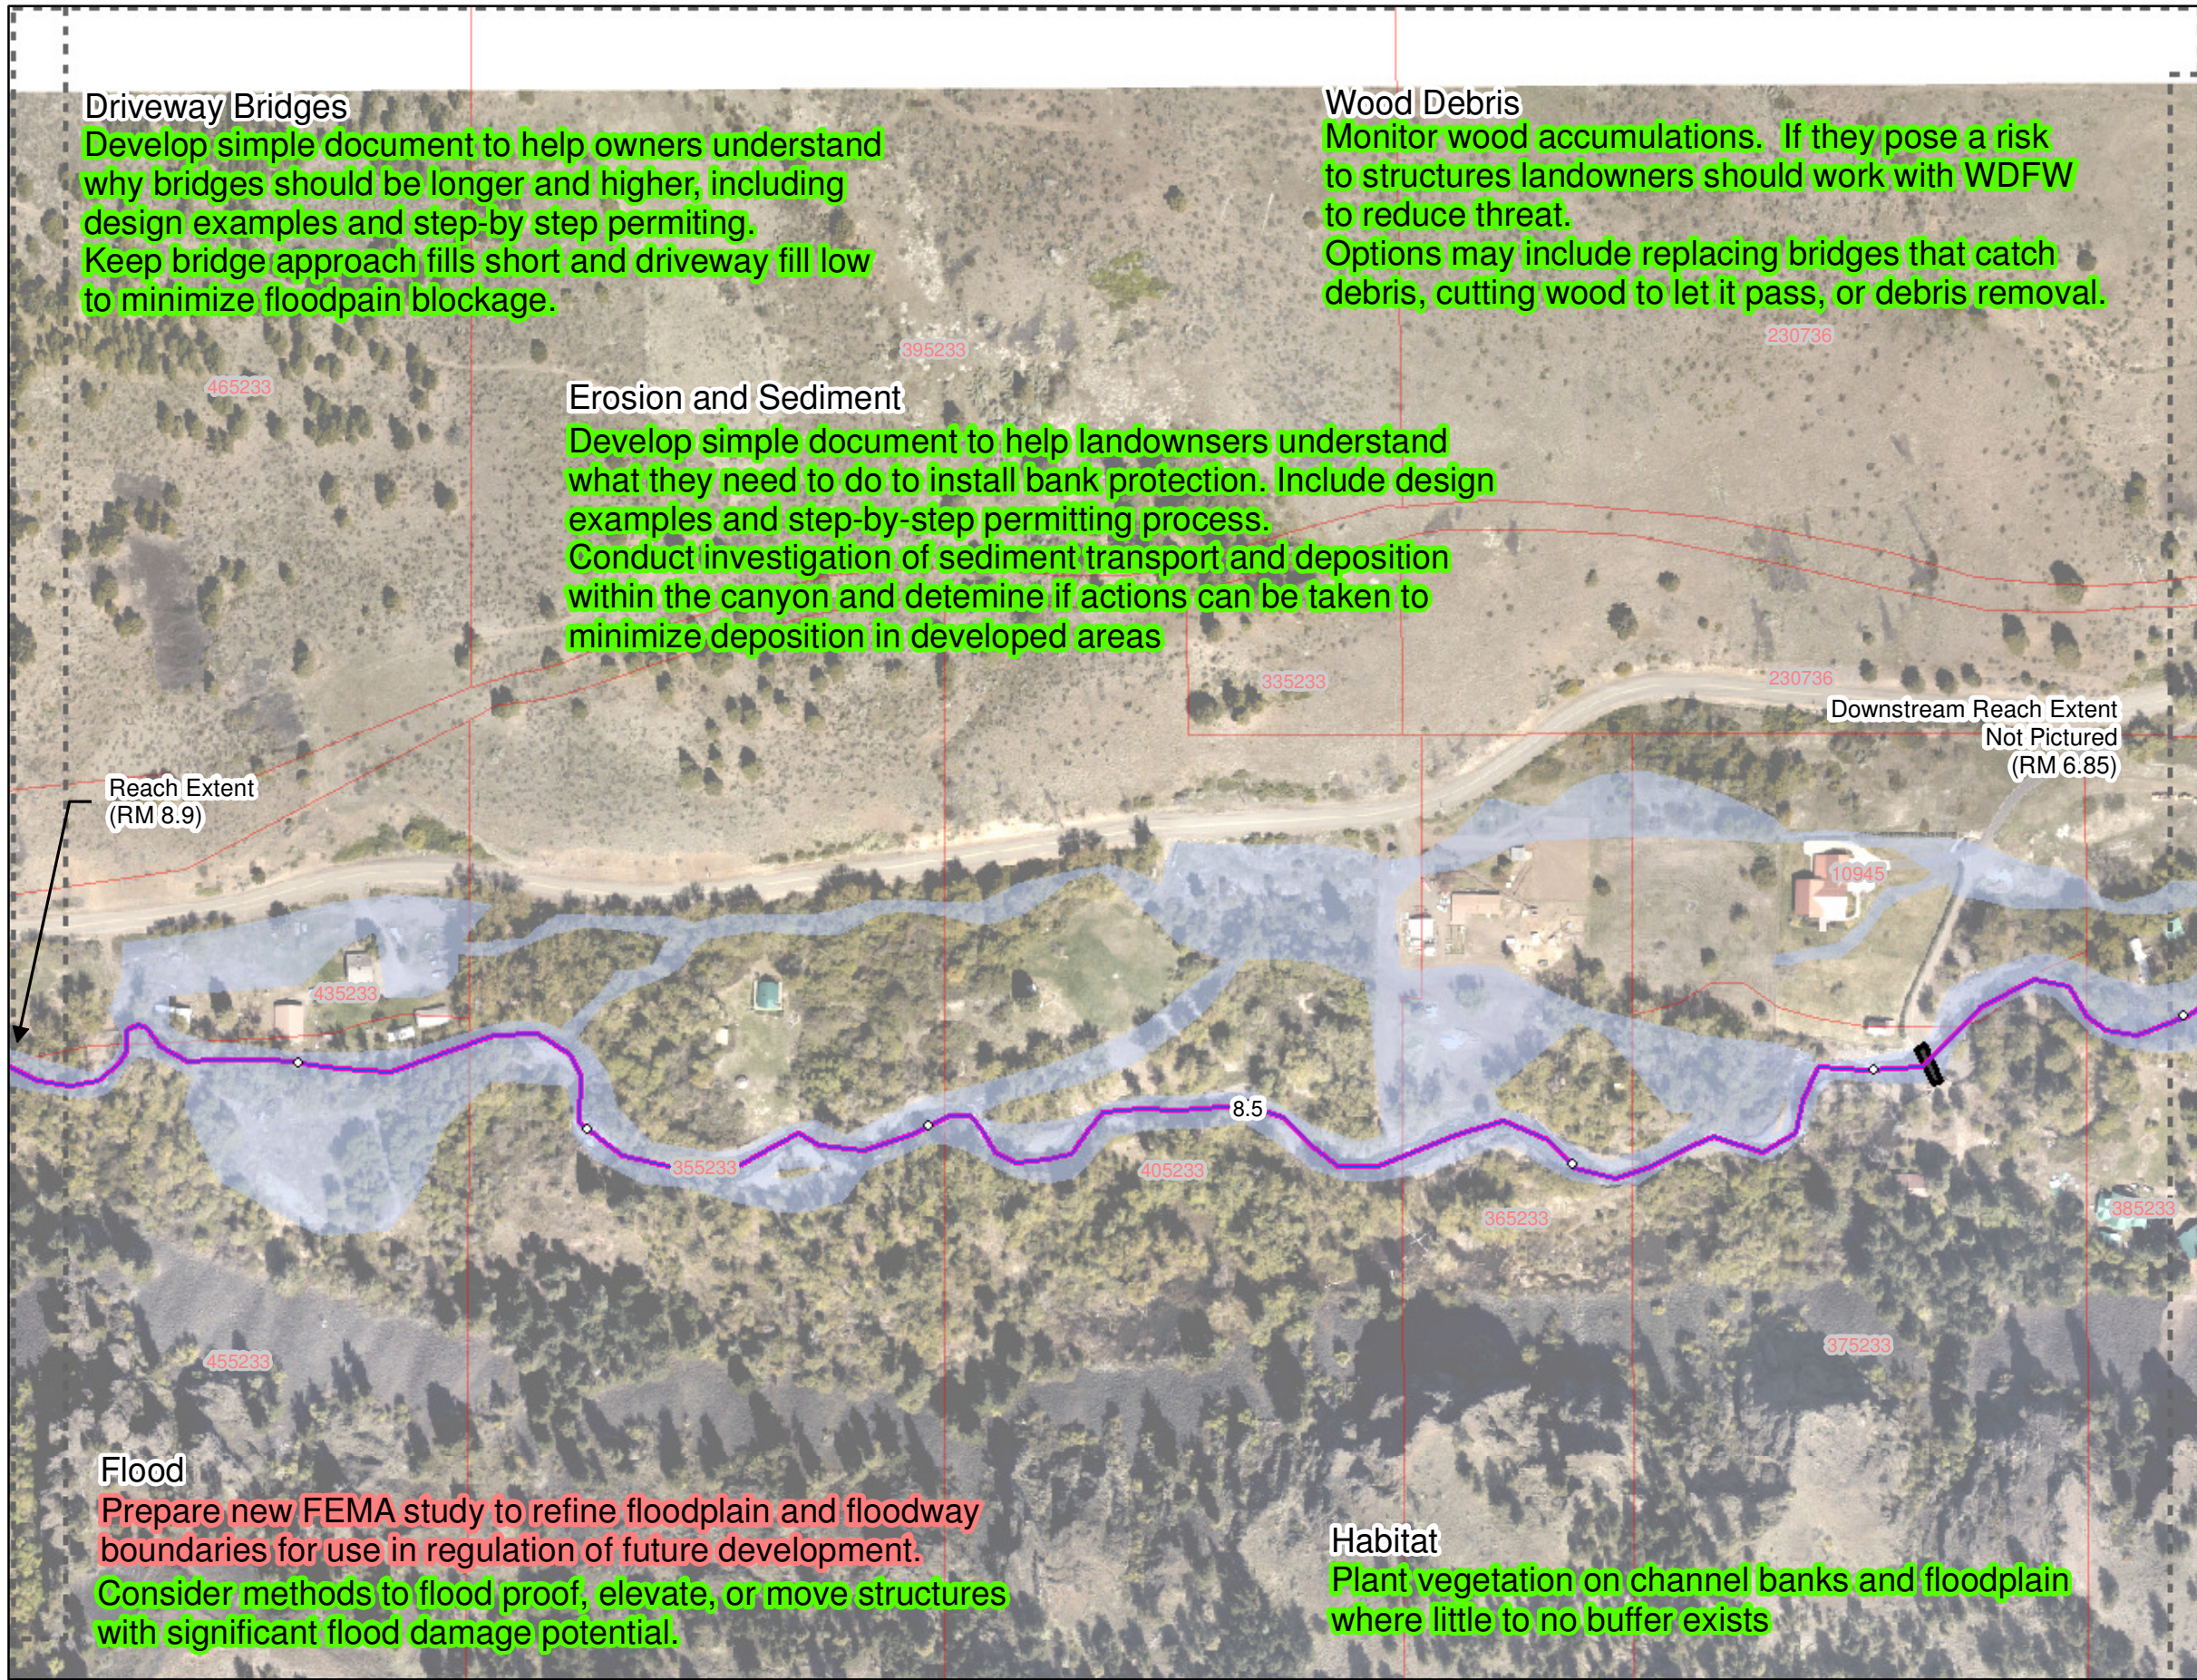
Develop simple document to help owners understand why bridges should be longer and higher, including design examples and step-by step permitting. Keep bridge approach fills short and driveway fill low to minimize floodpain blockage.

Monitor wood accumulations. If they pose a risk to structures landowners should work with WDFW to reduce threat. Options may include replacing bridges that catch debris, cutting wood to let it pass, or debris removal.

Develop simple document to help landowners understand what they need to do to install bank protection. Include design examples and step-by-step permitting process. Conduct investigation of sediment transport and deposition within the canyon and determine if actions can be taken to minimize deposition in developed areas

Reach Extent (RM 8.9)

Downstream Reach Extent Not Pictured (RM 6.85)

Prepare new FEMA study to refine floodplain and floodway boundaries for use in regulation of future development. Consider methods to flood proof, elevate, or move structures with significant flood damage potential.

Plant vegetation on channel banks and floodplain where little to no buffer exists
